Aviation Occurrence Investigation AO-2008-053

Interim Factual

**Depressurisation
475 km north-west of Manila, Philippines
25 July 2008
Boeing Company 747-438, VH-OJK**

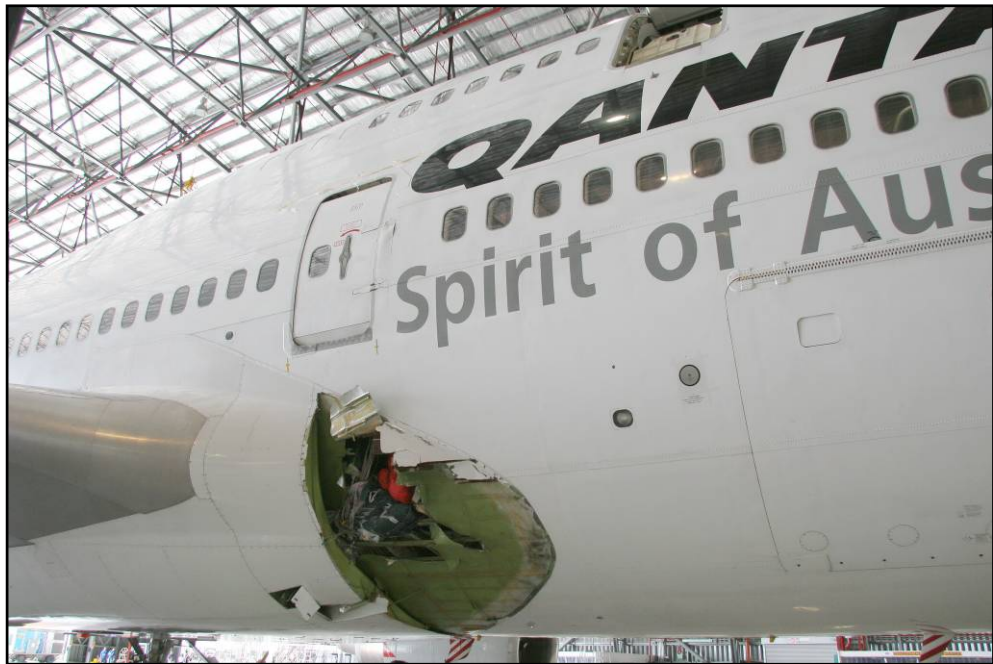
An initial inspection of the external aircraft surfaces on the ground in Manila revealed the complete loss of the right wing forward leading edge-to-fuselage fairing, with separation occurring along the lines of interconnection between the fairing and fuselage skins (Figure 1). In the area exposed by the fairing loss, was an inverted T-shaped rupture in the fuselage skin, with several items from within the forward cargo hold partially protruding from the rupture (Figure 2). The approximate vertical centreline of the skin rupture was positioned at fuselage station⁵ (STA) 820, with skin damage extending longitudinally for 79 inches (201 cm), from STA 777 to STA 856. Vertically, the rupture extended for approximately 60 inches (152 cm) between fuselage stringer⁶ 31 at the top, to stringer 38 at the lower extent of the damage. While some of the fuselage skin had folded outward and away from the rupture, it was evident that an area of skin and structure equal to approximately one-half of the total ruptured area had separated from the aircraft and was not recovered. On the basis of measurements taken around the ruptured areas, the total area of the skin rupture was estimated at around 1.74 square metres (2,700 square inches). Figure 3 illustrates the extent of the fuselage rupture as viewed from outside the aircraft.

Figure 1: Fuselage rupture – external view

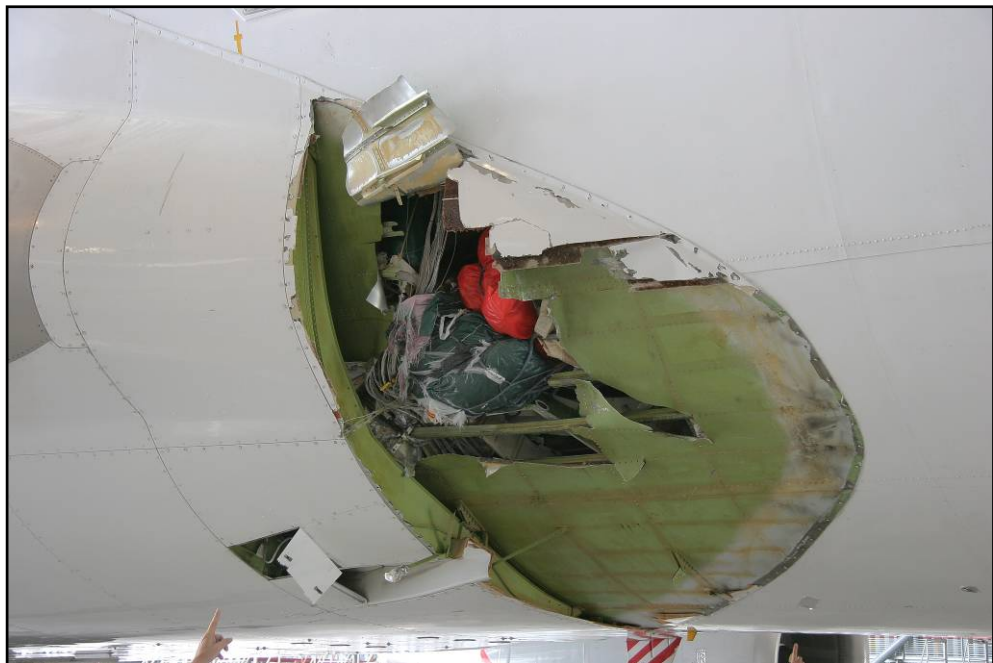
Figure 2: Fuselage rupture with protruding cargo

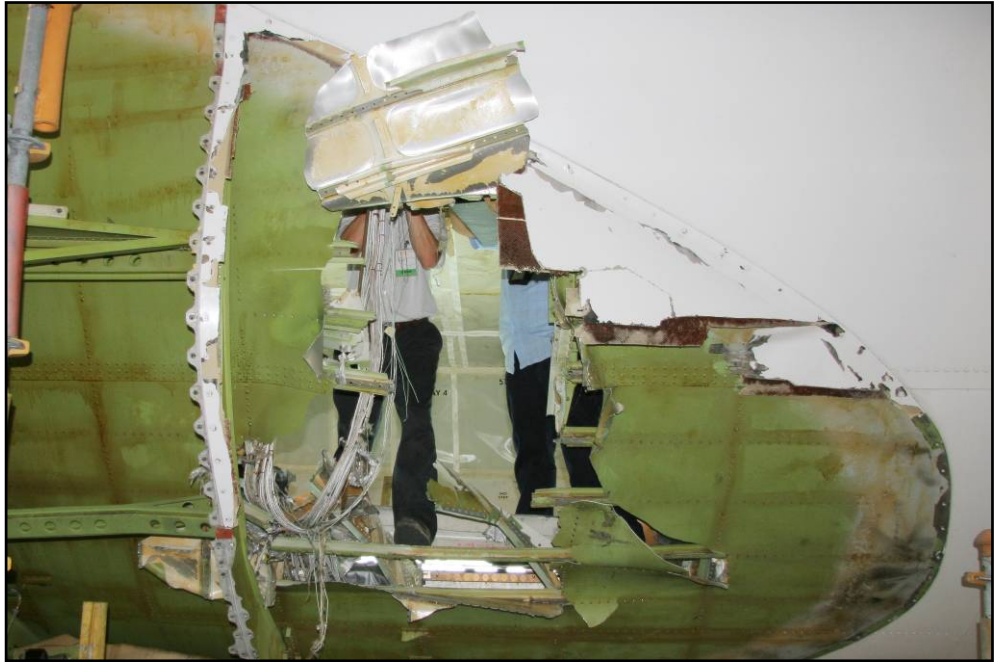
Figure 3: Extent of the fuselage rupture, after removal of further transition fairings

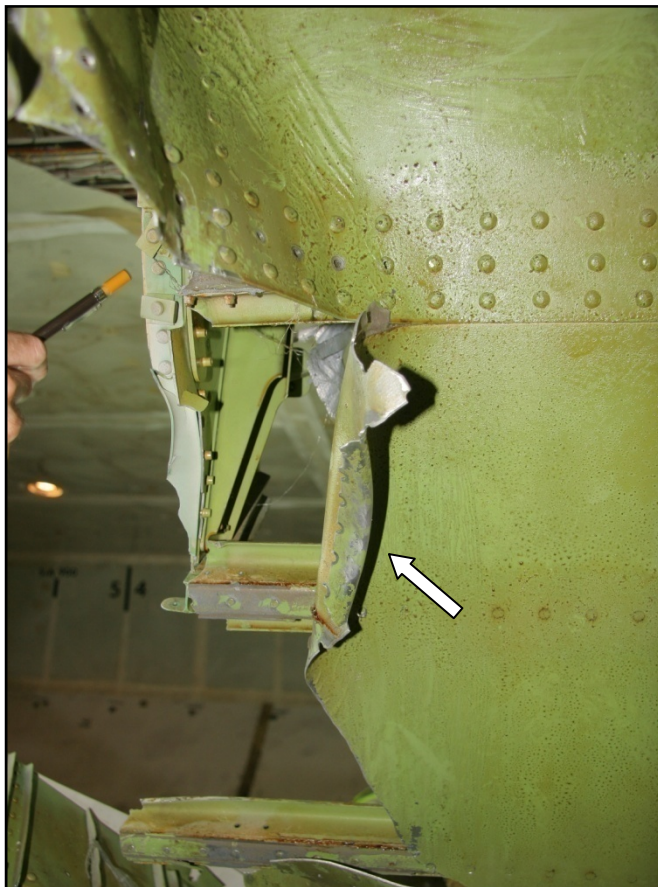
An examination of the rupture profile and fuselage skin damage found that all fractures were typical of a ductile tearing mechanism, with no evidence of corrosion, prior cracking or pre-existing defects in any of the areas examined. Along the forward edge of the rupture void, an area of skin presented a sharply folded appearance, with an outward curvature that appeared to match the profile of the breathing oxygen cylinders installed internally along the fuselage wall (Figures 4 and 5).

Figure 4: Sharply folded area of fuselage skin

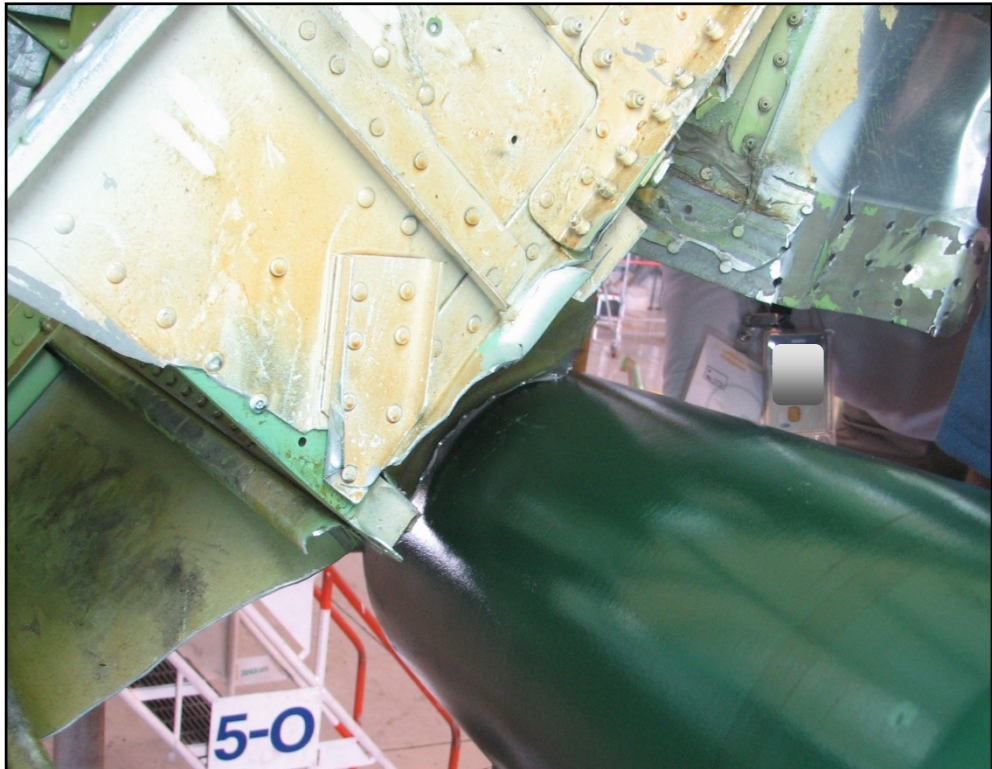
Figure 5: Oxygen cylinder held against skin fold to illustrate conformance

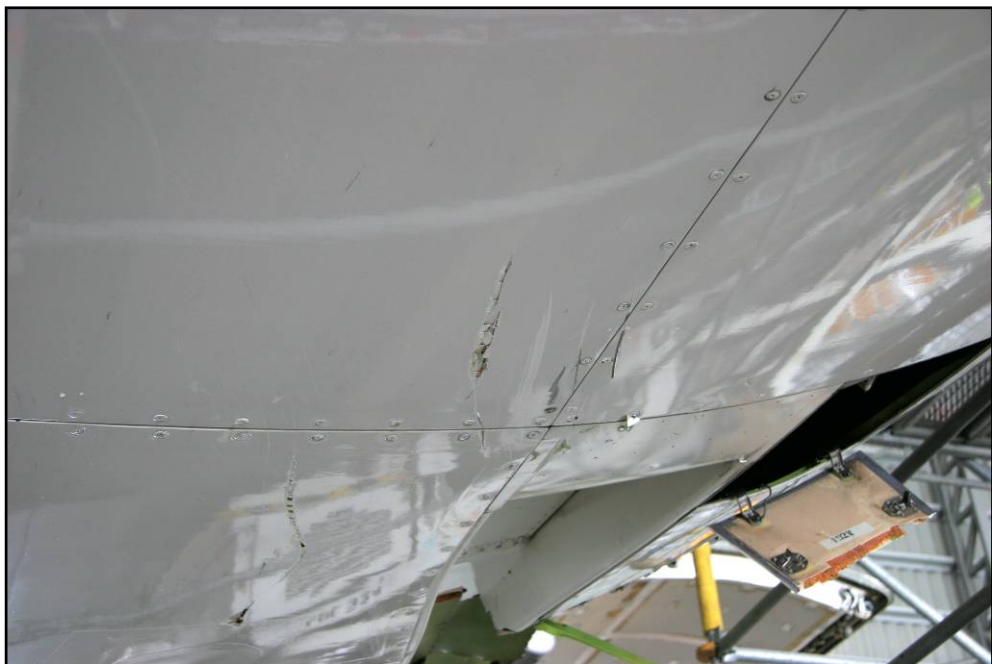
Rearward of the fuselage rupture, several localised areas of scuffing, puncture and scoring were evident along the underside of the aircraft, extending along a diagonal path from the ruptured area rearward toward the left body landing gear (Figure 6). Elongated score marks were also noted extending for several metres around the left side of the rear fuselage – typically around STA 1880 to STA 2000.

Figure 6: Panel damage to the rear of the rupture site

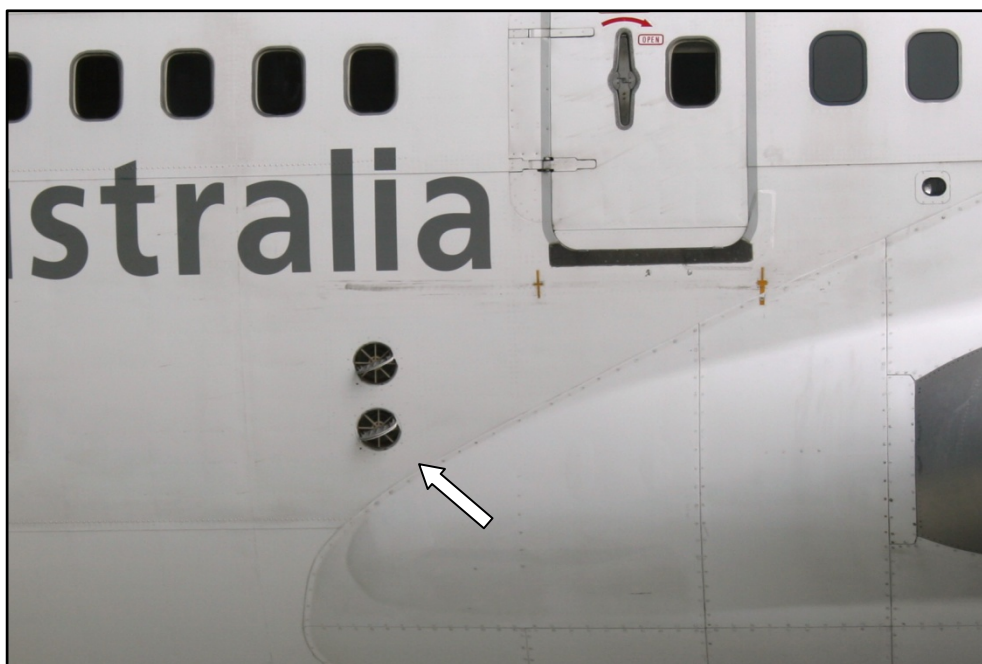
Figure 7: Pressure relief valve blowout doors open (arrowed)

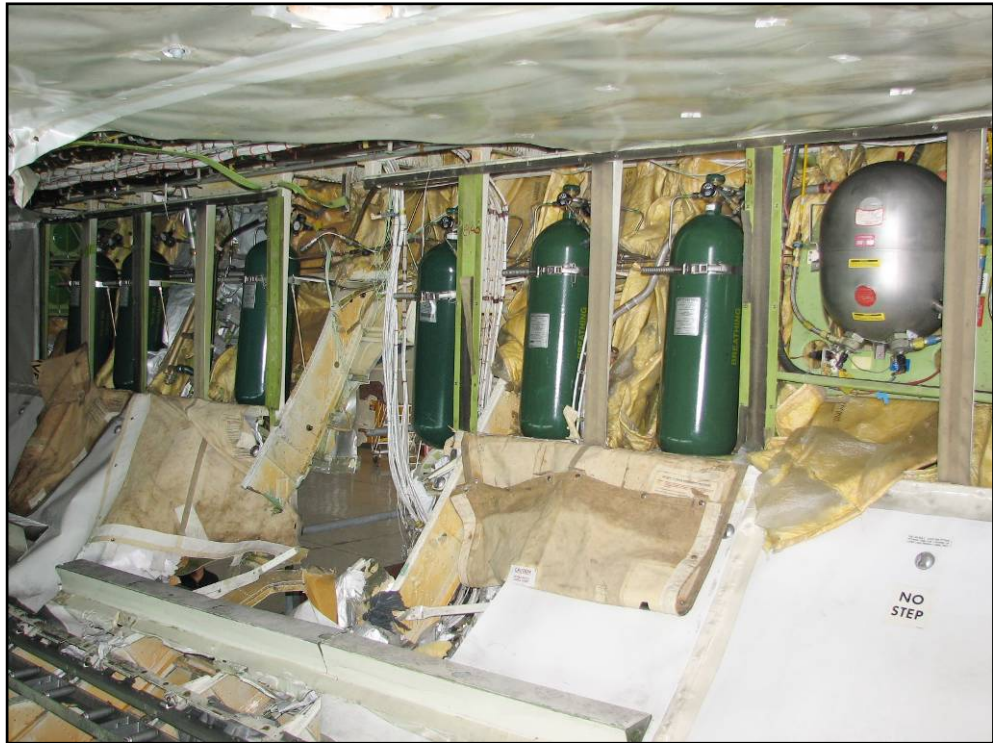
Figure 8: Forward cargo hold wall with remaining six oxygen cylinders

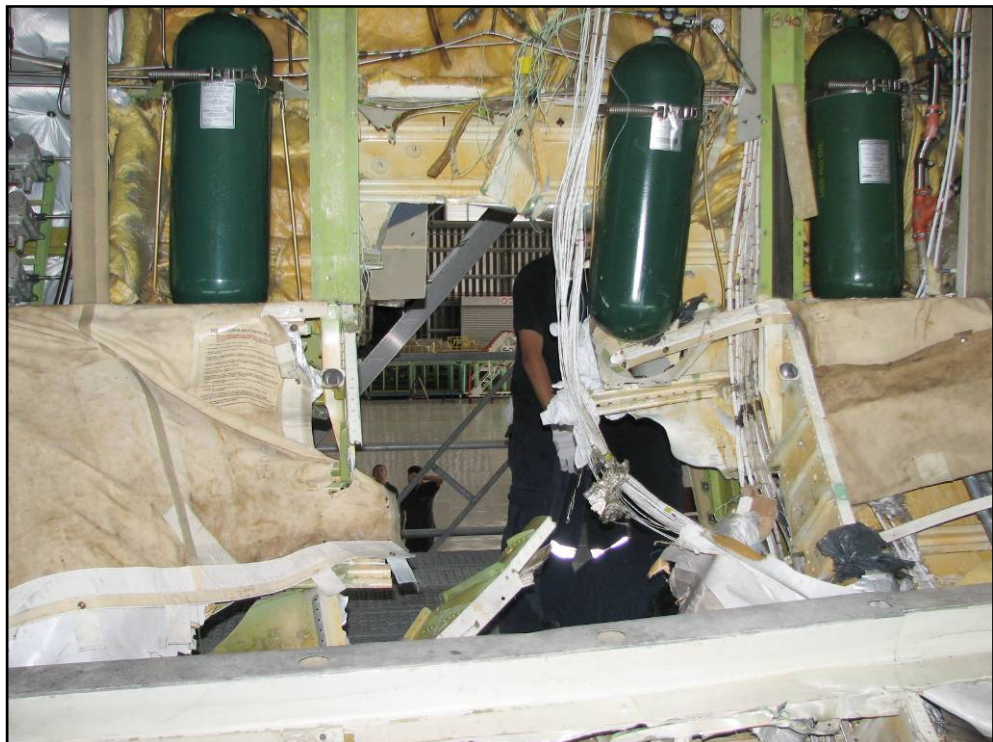
Following removal of all cargo materials and lowering of the hold right-side curtain panels, it was found that the fuselage rupture was aligned with the nominal position of the number-4⁷ passenger emergency oxygen cylinder; one of seven such cylinders in a bank along the right side of the hold (Figure 8). A further six cylinders were located in a central location within the ceiling of the cargo hold. The number-4 cylinder was missing from the bank, with the upper support bracket bent downward and both the retaining strap and lower cradle not present (Figure 9). The adjacent number-5 cylinder lower support cradle had been pulled downward and away from the cylinder as a result of the fuselage rupture. However, the upper cylinder mount and strapping remained secure and the cylinder gas connections intact (Figure 10).

Figure 9: Fuselage rupture coincident with mounting position of the number-4 oxygen cylinder

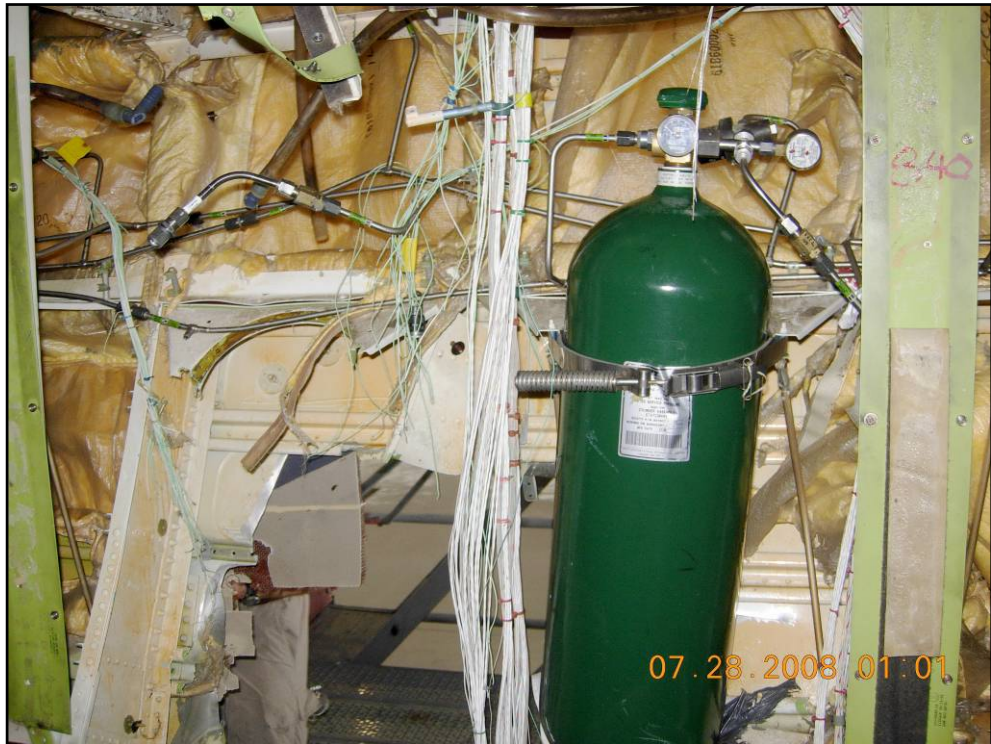
Figure 10: Number-5 oxygen cylinder adjacent to fractured fittings and lines from the number-4 cylinder

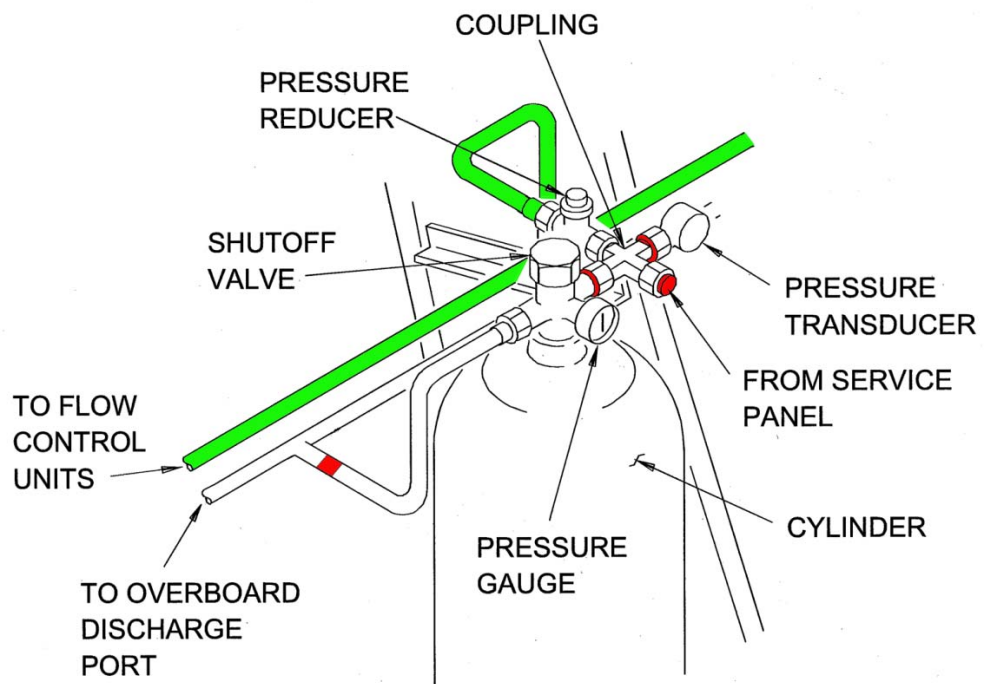
Each of the passenger oxygen cylinders had three connected stainless steel lines – an overpressure relief vent line, a delivery line and a service/filling line. The filling and delivery lines were fed through a tee-piece from a common cylinder connection, with a pressure regulator and transducer integral to the assembly. The number-4 cylinder valve had fractured and separated from the system lines in several locations around the valve assembly (Figure 11):

Figure 11: Oxygen cylinder and valve illustration – points of fracture marked in red, oxygen delivery line in green

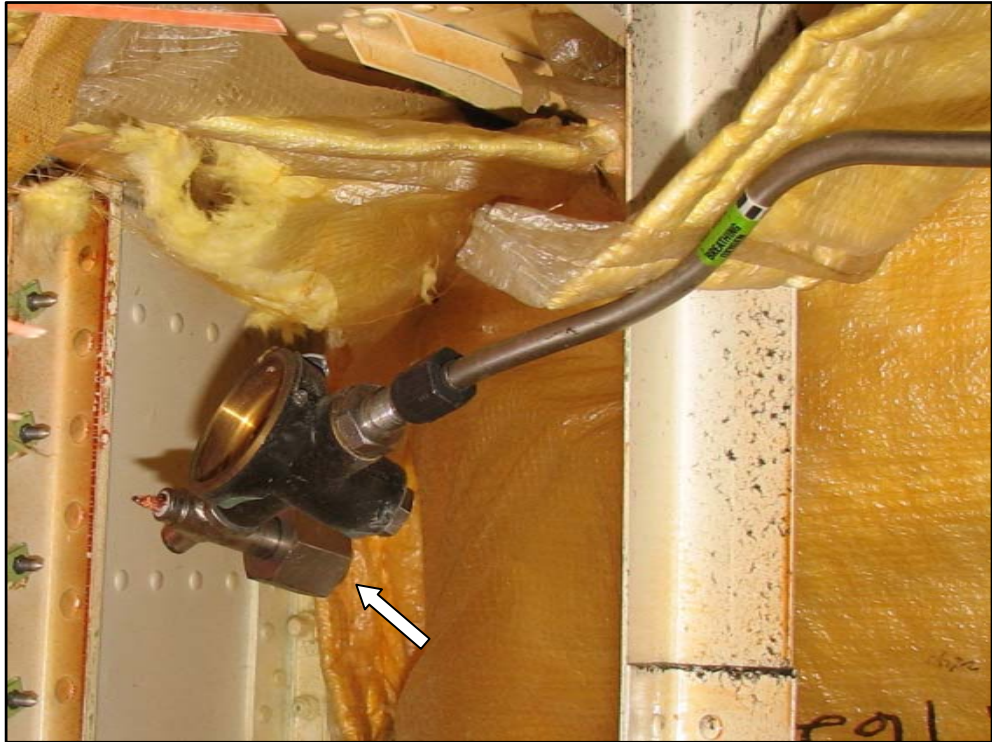
- the service/delivery T-piece had fractured from the cylinder valve outlet, with the damaged and partly intact pressure reducer remaining connected to the delivery line (Figure 12)
- the service line had fractured through the thermal compensator fitting at the service/delivery T-piece (Figure 13)
- the overpressure relief vent line had fractured immediately before its connection into the common line for the cylinder bank (Figure 14). The green indicator

Figure 12: Number-4 cylinder pressure reducer and tee-piece - fractured away from cylinder valve at arrowed connection

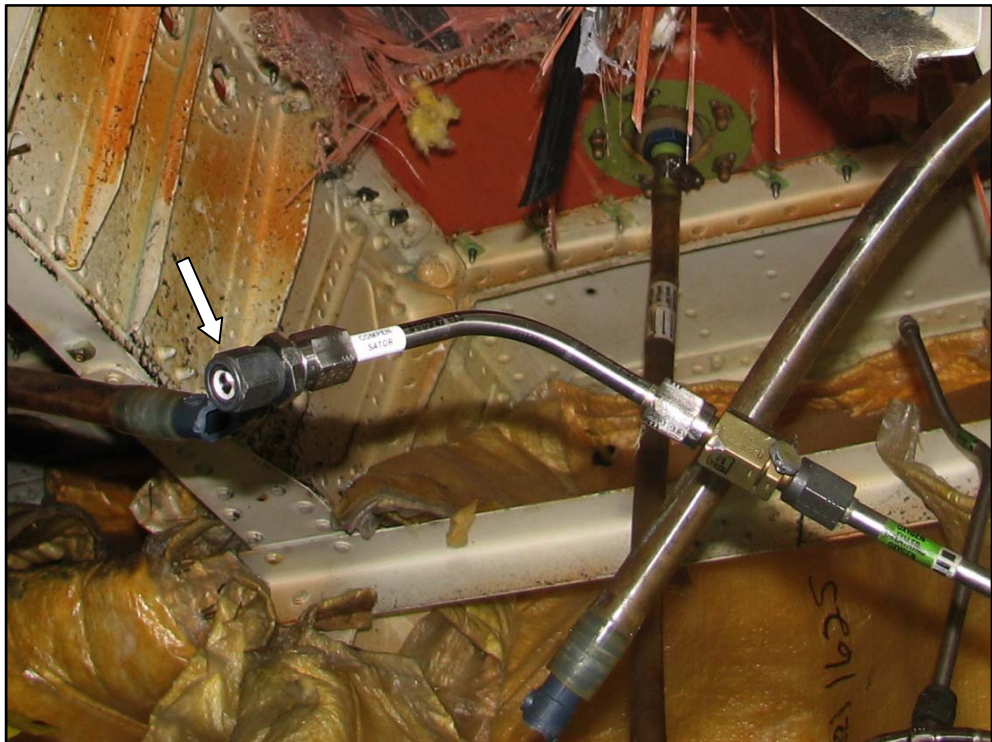
Figure 13: Number-4 cylinder service line fracture (arrowed)

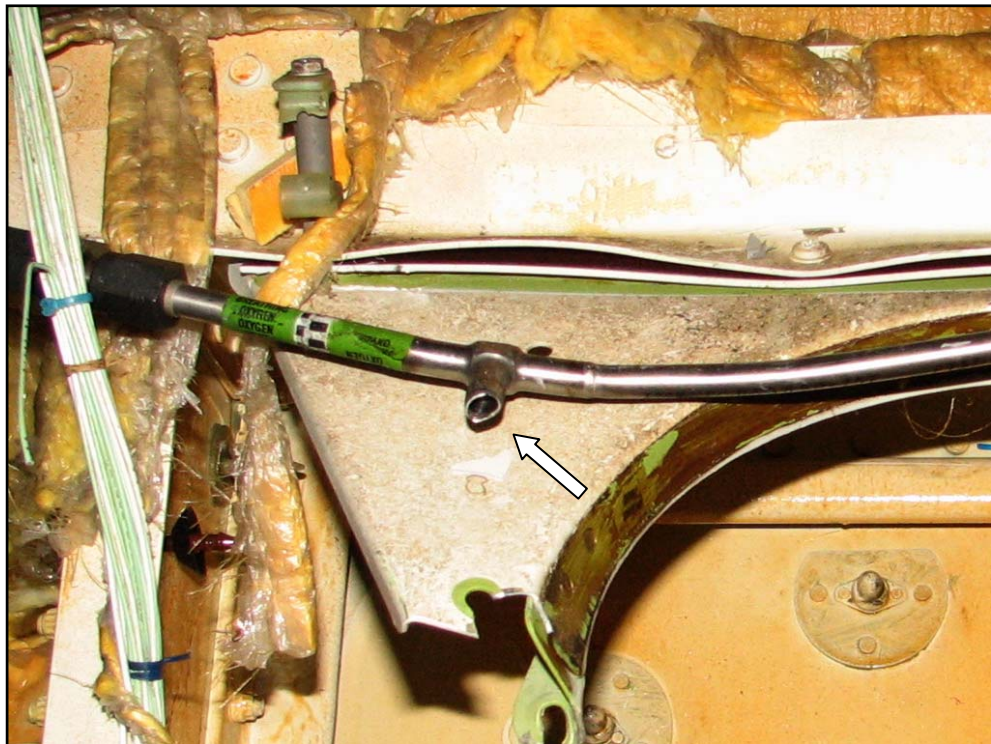
Figure 14: Number-4 cylinder overpressure discharge line fracture (arrowed)

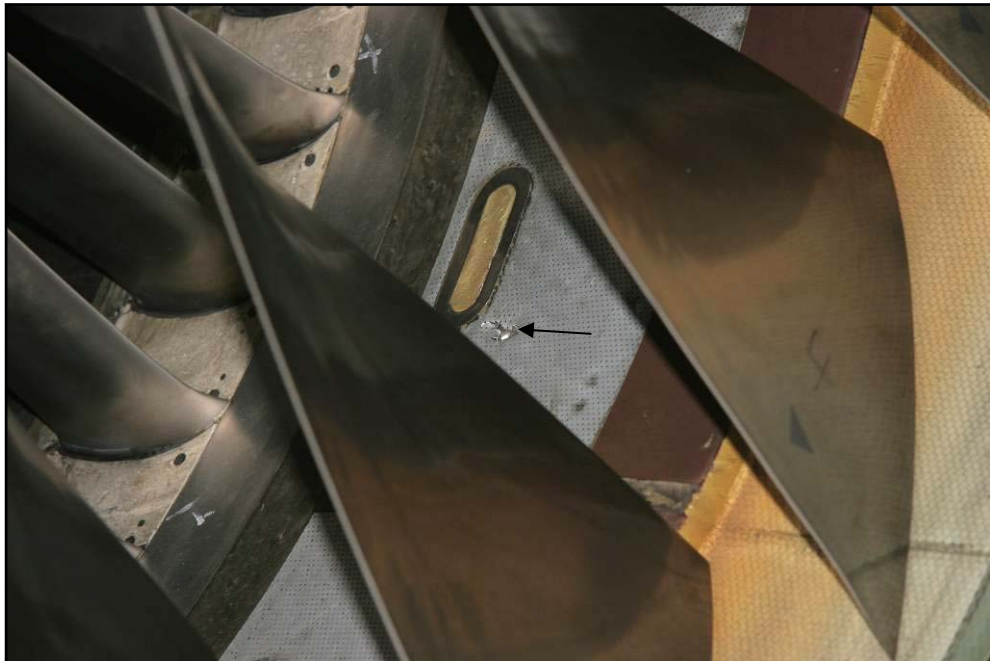
Several small pieces of structural honeycomb material of the type comprising the wing leading edge fairing were found trapped around the edges of panels within the left side of the number-3 engine pylon (side facing the rupture). A small indentation and cut was found within the number-3 engine intake acoustic panelling, located immediately inside the plane of rotation of the engine fan (Figure 15). There was no evidence of damage to the fan blades themselves, nor was there any evidence of the ingestion of debris into the engine core.

Figure 15: Damage to acoustic lining (arrowed) behind the number-3 engine fan

The aircraft operator reported that an internal boroscopic inspection of the engine while in Manila, identified some damage to the turbine components, although the nature of the damage suggested that it was unrelated to the depressurisation event. The engine was changed as a precaution.

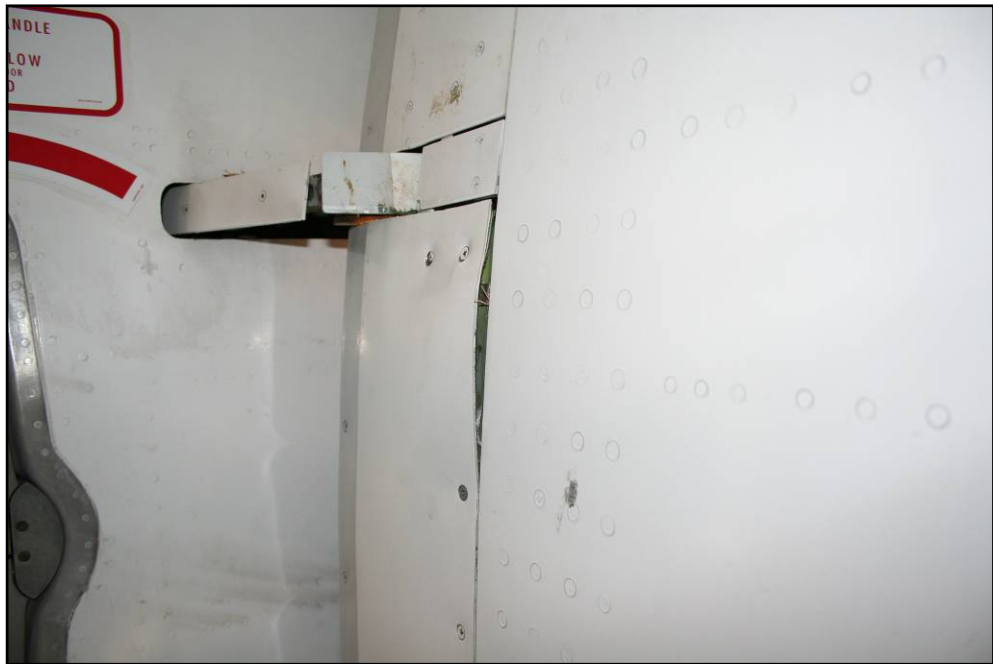
The R2⁸ door into the aircraft's main cabin was located directly above the fuselage rupture (at STA 830). An external panel located between the two door hinges showed localised outward bulging from a point immediately below the upper hinge, with the forward edge of the panel raised above the surrounding fuselage skin (Figure 16). The main external door handle was in the fully closed position, however the upper and lower door gates⁹ were partially retracted.

Figure 16: Cabin R2 door – damage to external panelling

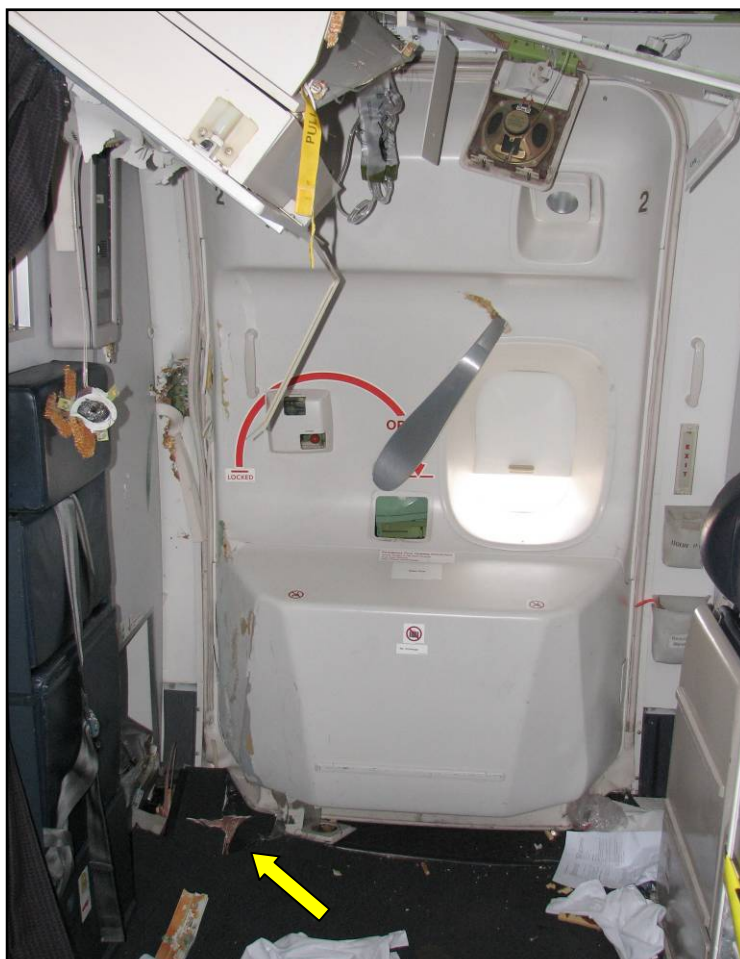
Within the aircraft, the cabin around the R2 door had sustained substantial damage and disruption (Figure 17). The cabin floor to the left and immediately inside the R2 door frame had sustained an impact that created a single circular perforation approximately 20 cm (8 inches) in diameter, located immediately above the number-4 oxygen cylinder position (Figure 18). Fragments of the cabin flooring and covering extended down into the hole. Above the hole, the forward partitioning panel between the door and the row 26J and K seats showed an elongated green coloured abrasion, leading upward to an area of impact damage at the mid-height position of the forward R2 door frame (Figure 19). The door escape slide shroud (bustle) also showed vertically-oriented scoring and green smear marks along the corner and forward facing surface. The portable walk-around oxygen cylinder normally located in an alcove just inside the R2 door was not present and was not accounted for in a subsequent search of the aircraft.

Figure 17: Interior of R2 door and cabin – location of floor hole arrowed

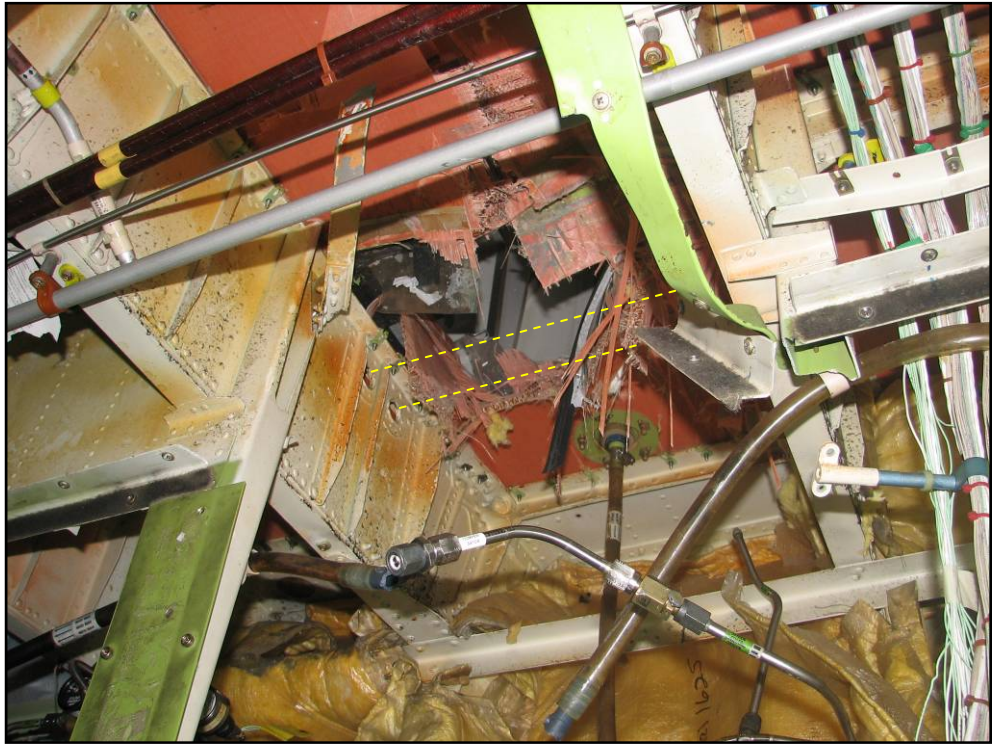
Figure 18: Hole in cabin floor – viewed from position of number-4 oxygen cylinder. Broken yellow lines mark the normal route of the first officer's aileron control cables

Both right side (first officer's) aileron control cables, routed along the right side of the fuselage above the passenger oxygen cylinders, had been fractured during the rupture event. All separated cable ends showed the irregular splaying and unwinding of the cable wires; characteristic of a tensile overstress failure. The nature of the cable failure and the proximity of the cable route to the cabin floor damage immediately above the number-4 oxygen cylinder location (Figure 18), indicated that the cables had been fractured as the cylinder was projected upward after rupturing.

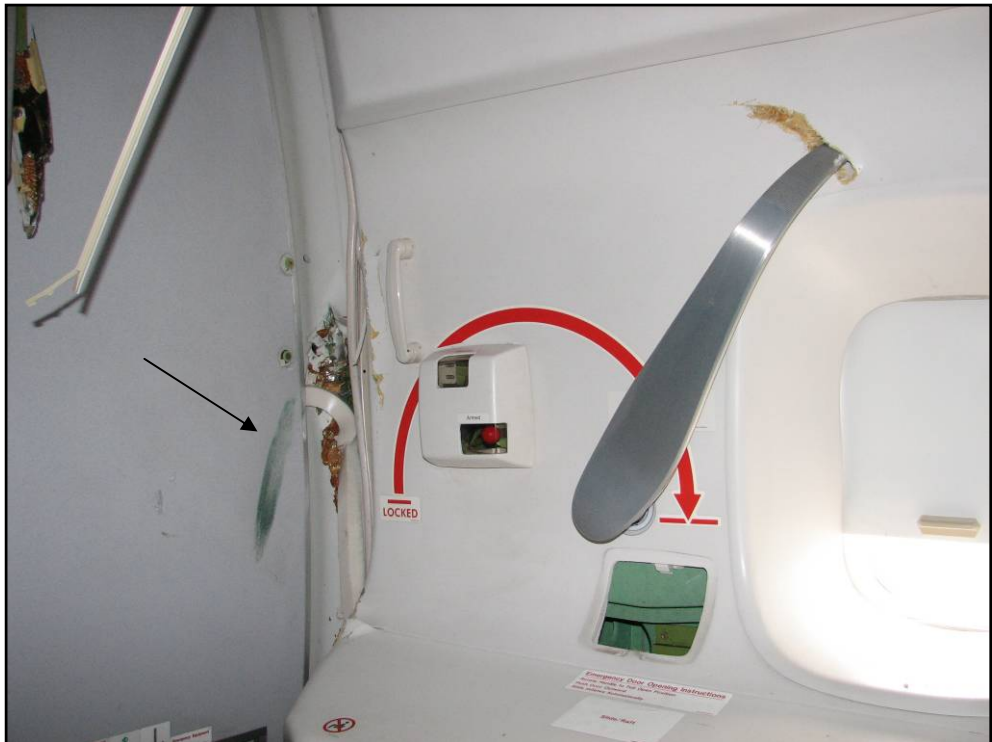
Figure 19: Door frame damage, green paint smear and rotated R2 door handle

The internal door handle was found in approximately the one-o'clock position (looking from inside), with the turned-in handle end embedded into the door lining material. That position was consistent with a movement through approximately 120 degrees from the fully-closed (locked) position. A 180 degree handle movement represented the fully open position. The downward facing surfaces of the handle end (when the door is in the locked position) showed damage and abrasion consistent with impact against another object. Inspection of the internal door systems showed the handle shaft had fractured and the actuating cam plate and retainer had pulled away from its associated mechanism (Figure 20), allowing the handle to rotate freely. As such, the handle position as observed inside the cabin was not indicative of the actual door security.

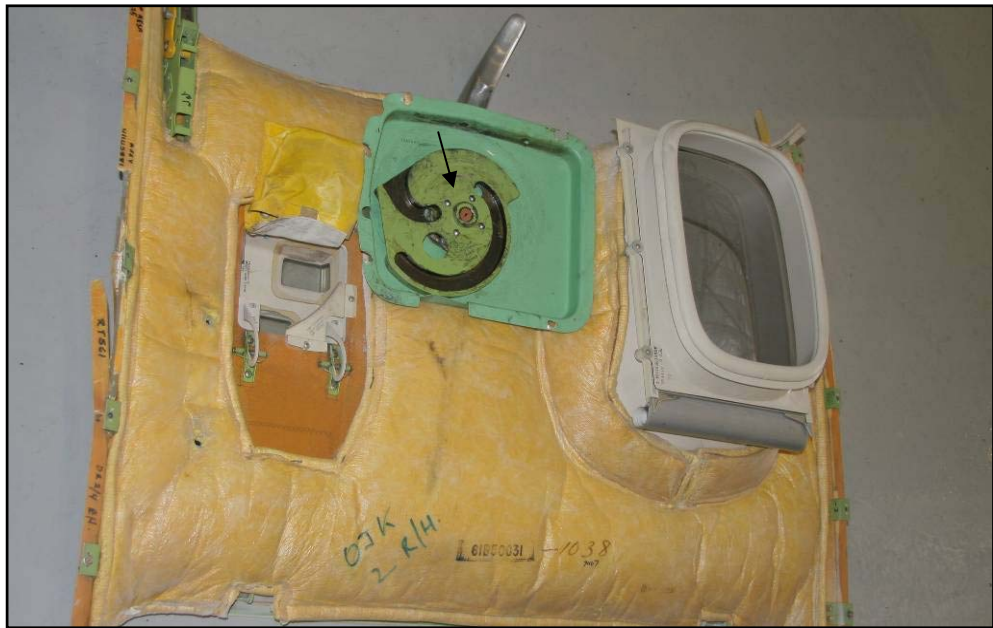
Figure 20: R2 door panel underside – fractured shaft and separated plate

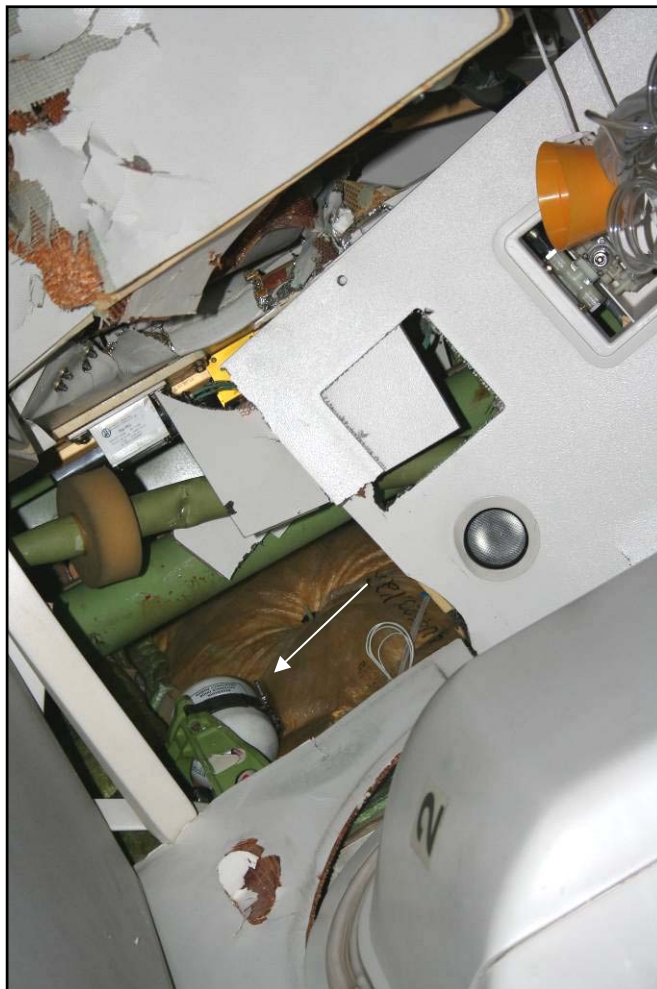
Above the R2 door within the cabin, the overhead panelling, fixtures and utility storage compartments had sustained extensive impact damage. The panels above the door frame had been pushed inward, exposing the overhead structure and pressure reservoir for the door emergency power assist opening system (EPAS, Figure 21). Amongst the impact damage, it was observed that an unusually uniform semi-circular section had been forcibly cut from the panelling and access door (Figure 22), with the cut-out section later recovered from above the damaged storage compartment casing. The diameter of the cut-out region closely matched that of the passenger oxygen cylinders (Figure 23). Adjacent to the cut-out opening was a semi-circular area of crushing damage to a partitioning panel (Figure 24); the damage being of a similar diameter to the cut-out section. A light fitting, normally present in the overhead panels had sustained upward crushing damage and presented clear green paint smears of a similar colouration to the marks on the partition panel and door bustle.

Figure 21: Damage above R2 door, exposing the EPAS cylinder (arrowed)

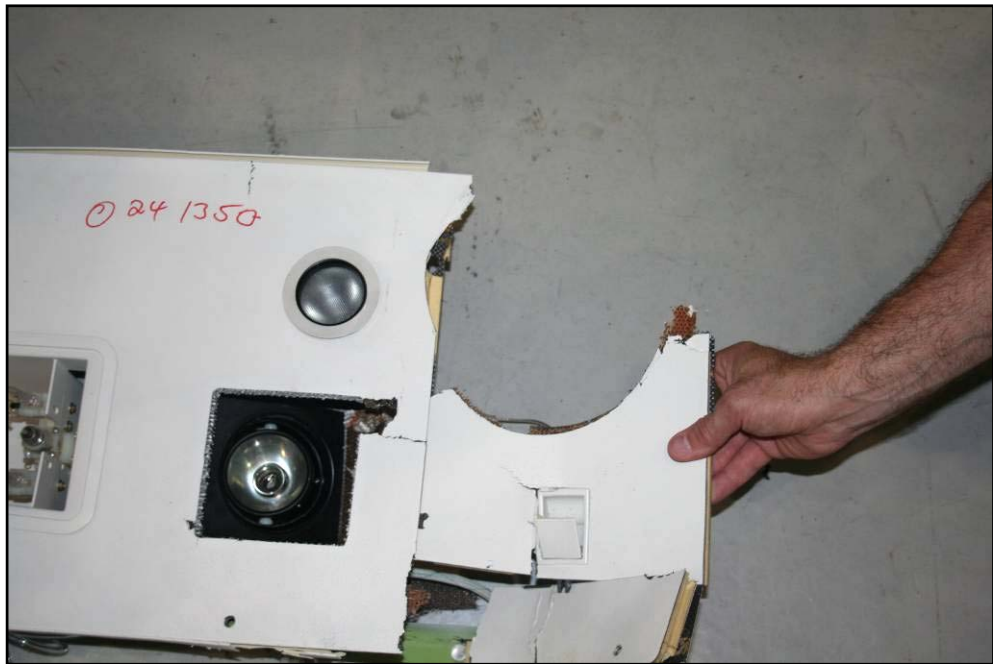
Figure 22: Cut-out section found in panels above the R2 door

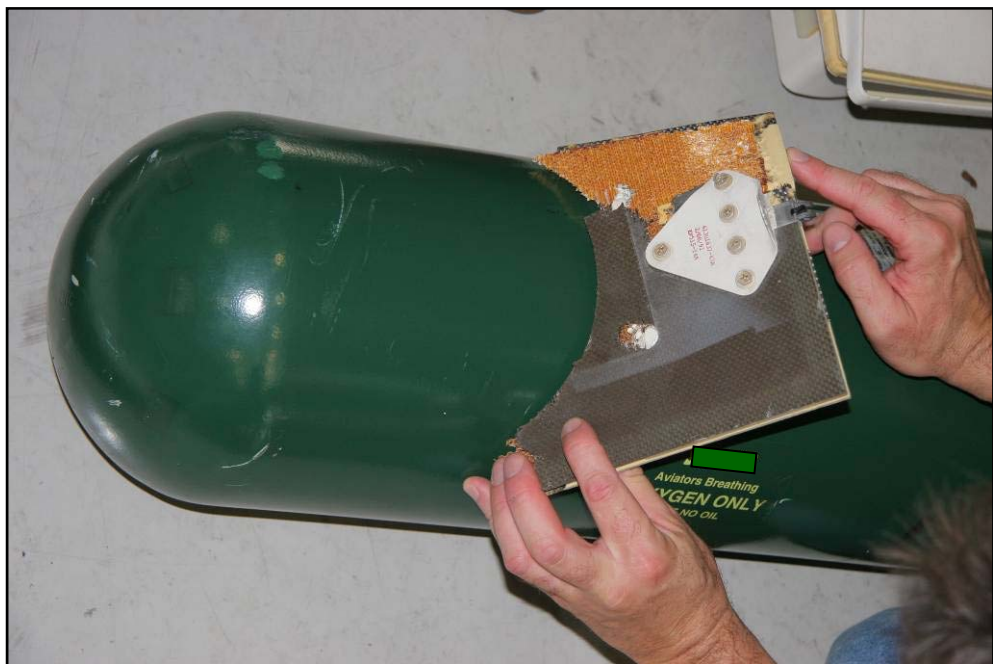
Figure 23: Panel with cut-out placed against another oxygen cylinder to illustrate the conformance in diameter

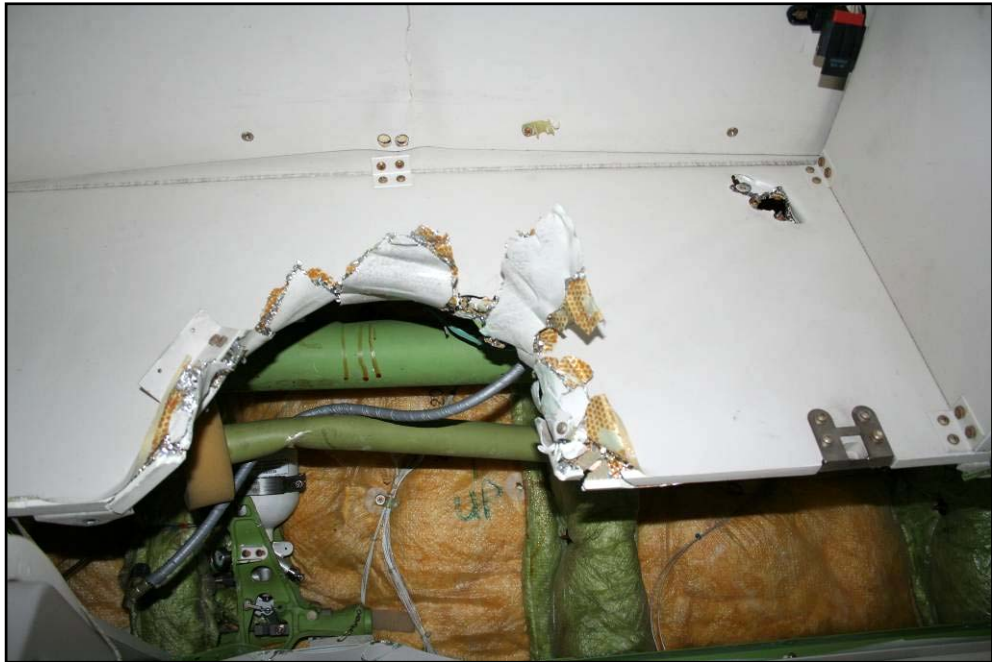
Figure 24: Semi-circular damage in partition of compartment above R2 door

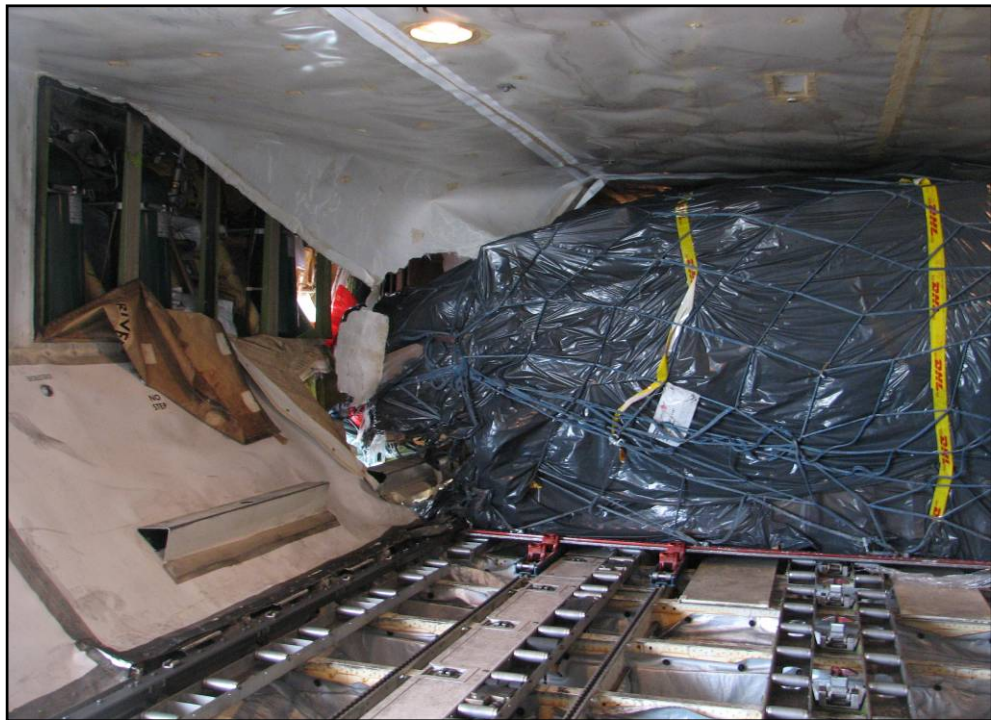
Figure 25: Cargo pallet adjacent to fuselage rupture (view looking to the rear)

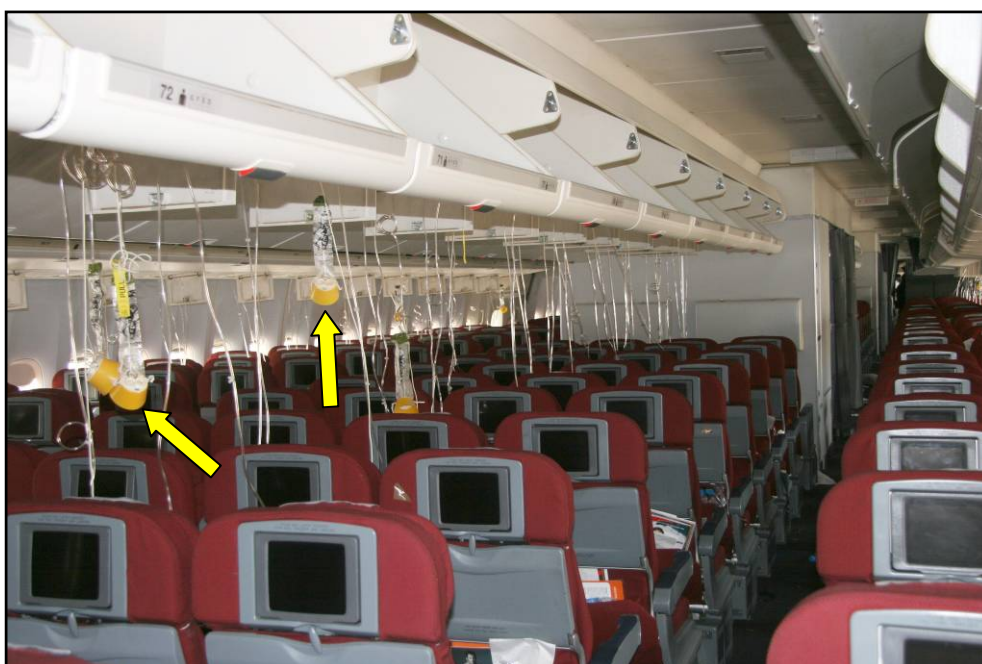
Figure 26: Typical appearance of the cabin after arrival in Manila. Note the passenger masks dropped and activated, and those dropped and not activated (arrowed)

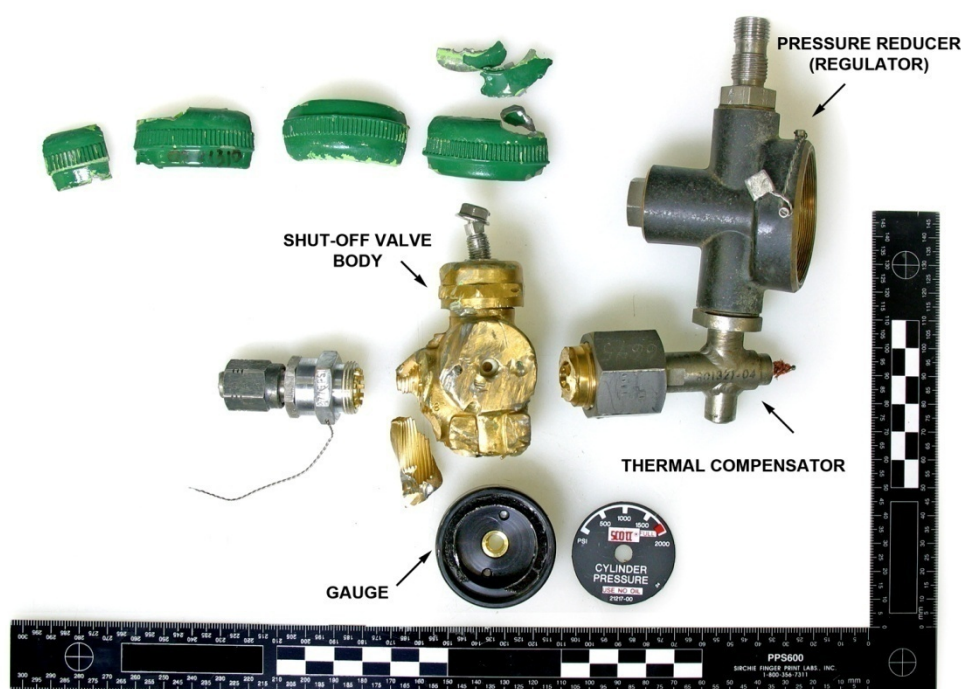
While the entire body of the number-4 passenger oxygen cylinder had been lost from the aircraft, a number of damaged fragments and components from the valve assembly were recovered from the aircraft cabin, or remained attached to the pipe-work servicing the missing cylinder (Figure 27).

Figure 27: Cylinder number-4 valve and related components and fragments recovered

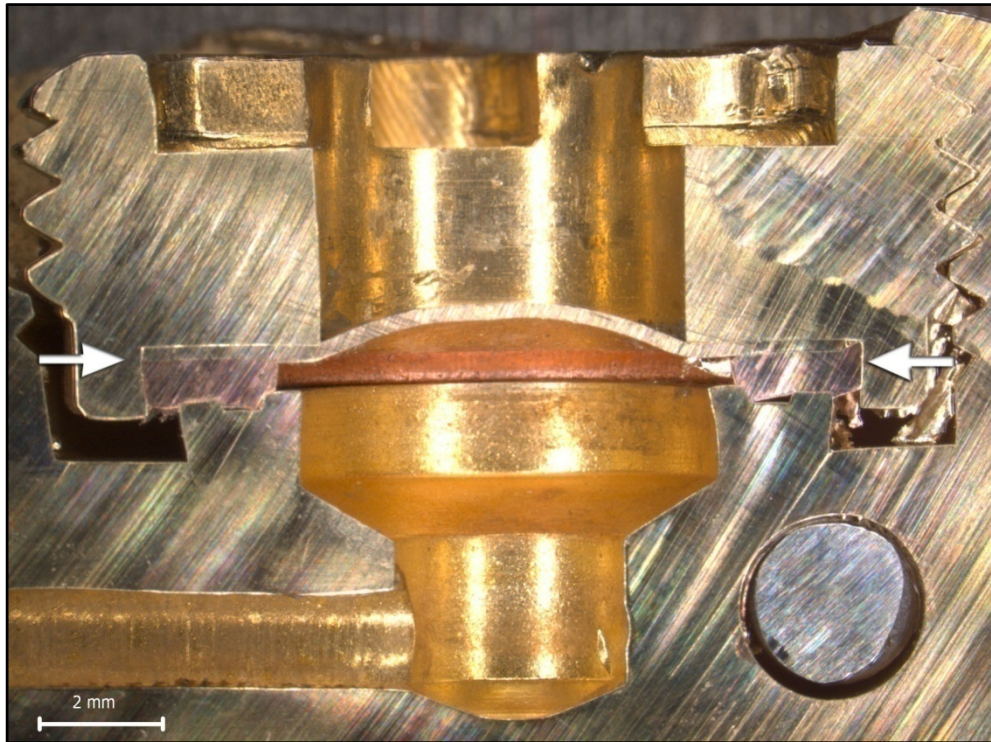
Figure 28: Transverse section through the frangible disk (arrowed) and retaining assembly from the number-4 cylinder. The outward curvature is typical of normal service.
