Aviation Occurrence Investigation AO-2008-053

Interim Factual

**Depressurisation
475 km north-west of Manila, Philippines
25 July 2008
Boeing Company 747-438, VH-OJK**

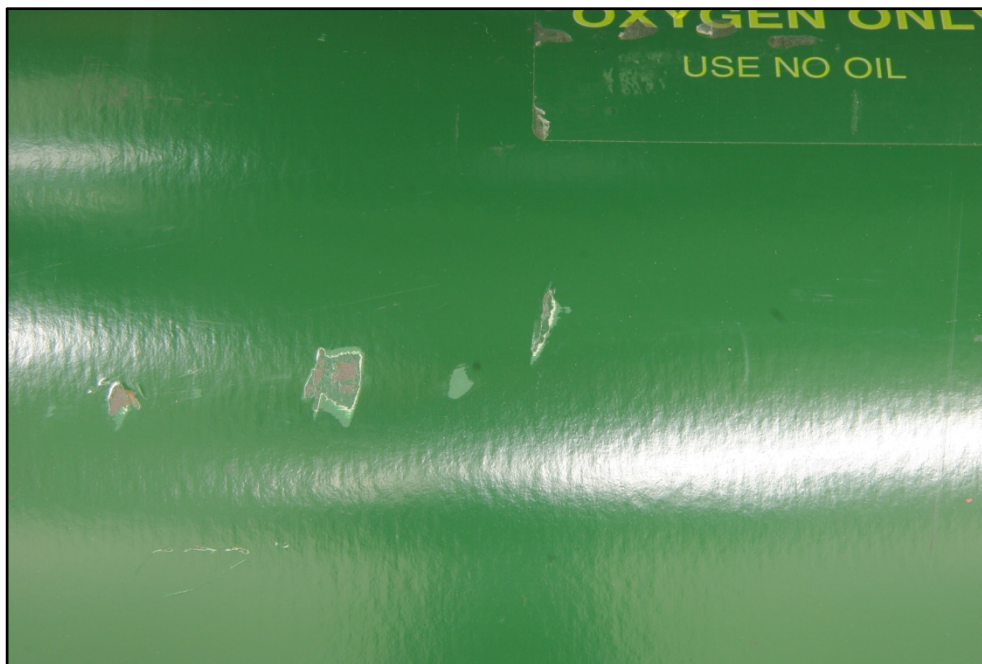
In general, all items presented only isolated light external surface abrasions, scrapes and rub marks, with localised paint removal and superficial corrosion in some areas (Figure 29). Damage to the underlying steel in those areas was not evident. The largest of the individual marks measured approximately 10 x 10 mm (0.4 x 0.4 in), although multiple such marks were sometimes evident in clusters or lines.

Figure 29: External surface marks on exemplar cylinder SN: 535598

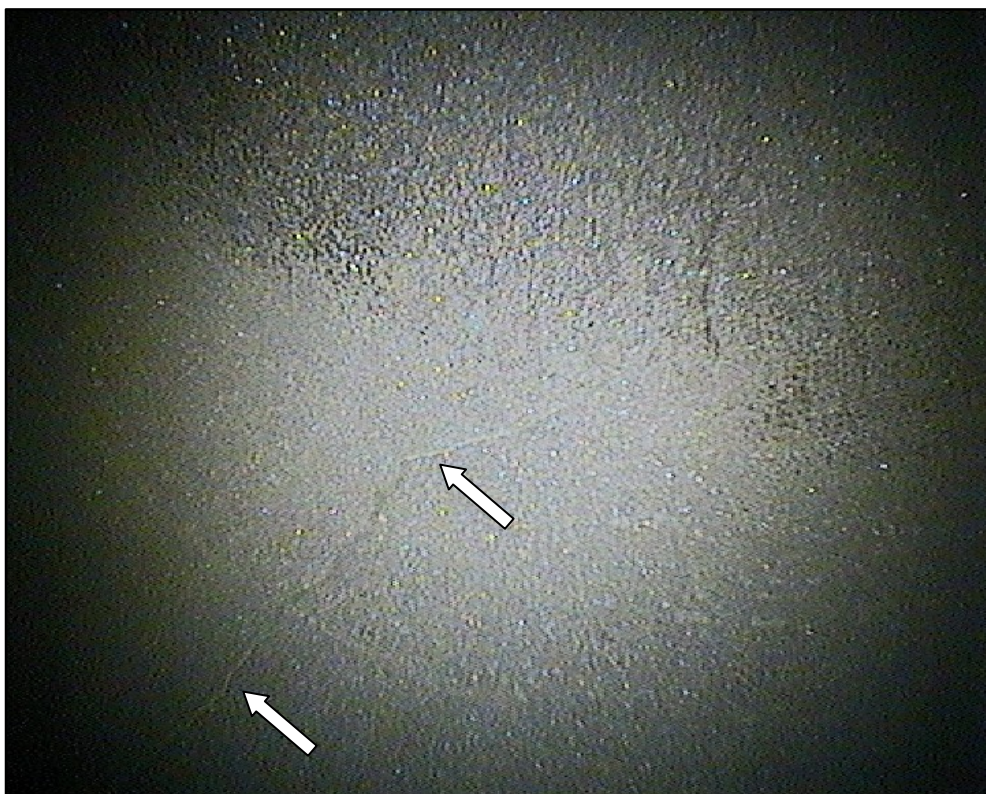
Figure 31: Linear feature observed inside cylinder SN: 535626 (arrowed)

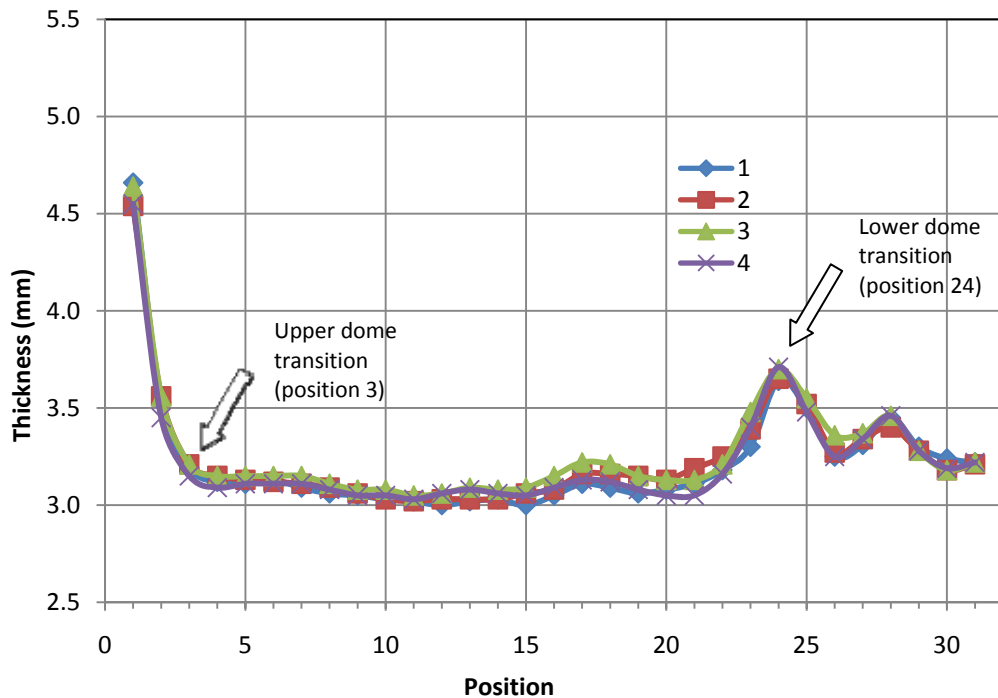
Of the cylinders examined, SN: 535667 presented the lowest nominal wall thickness, with a minimum recorded value of 3.0 mm (0.118 in); 0.13 mm (0.005 in) above the prescribed 2.87 mm (0.113 in) minimum wall thickness. Figure 32 presents the survey results for this cylinder graphically. In general, the minimum wall thickness was found within the central regions of the cylinder body, although the variability was minimal (typically ± 0.1 mm, 0.004 in) along the body length. The thickness measurements also highlighted the presence of a localised increase in thickness of around 0.5 mm (0.02 in) around the lower dome transition.

Figure 32: Thickness survey data for cylinder SN: 535667

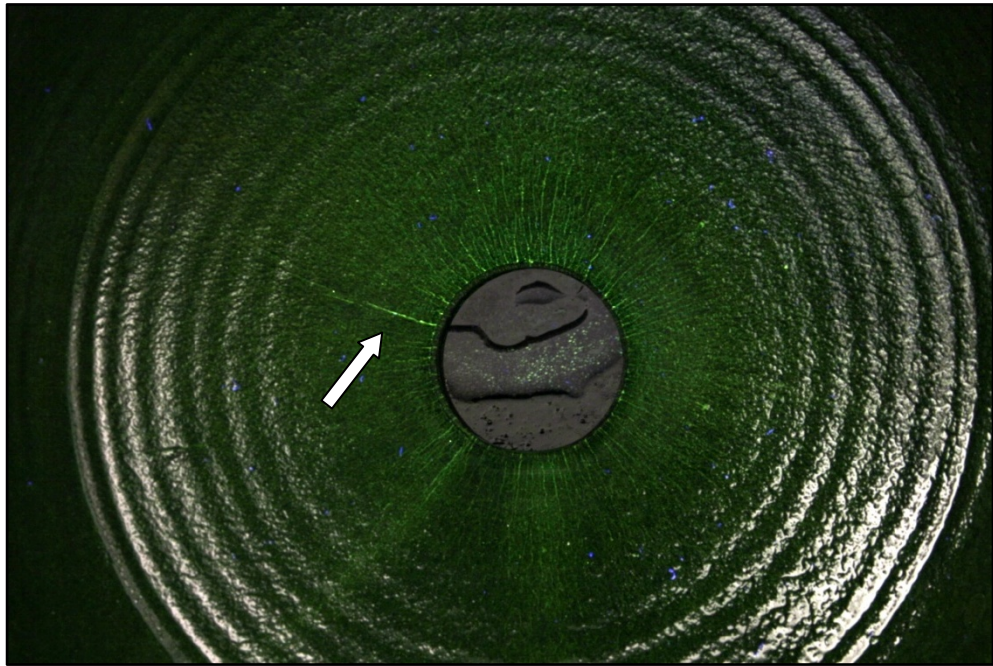
After sectioning cylinder SN: 535626 to expose the internal surfaces, a fluorescent magnetic particle technique was employed to examine 100% of the internal surface area, including the linear feature observed during the endoscopic examination (Figure 31). While no evidence of crack-like features was observed within the cylinder body, multiple linear indications were detected radiating outward from the cylinder neck transition region (Figure 33). The longest of the indications extended for approximately 12 mm (0.5 in).

Figure 33: Linear indications extending from the internal neck bore of cylinder SN: 535626 (largest arrowed)

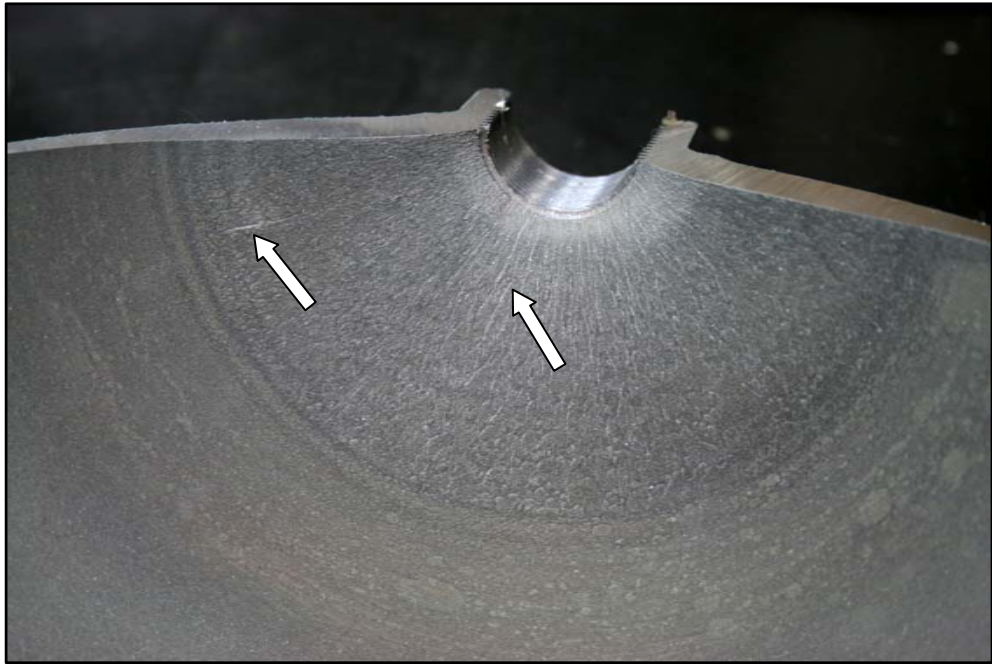
Prior to further sectioning for microstructural study, the internal surfaces of cylinder SN: 535626 were examined visually. It was noted that the internal surfaces at, and around the upper dome and neck transition, displayed a considerably coarser and irregular surface finish when compared with the general cylindrical and lower dome surfaces. A radial pattern of fissures and rivulet features was observed, becoming more prominent toward the neck (Figure 34). The entire surface in the region presented an oxidised or thick scale-like appearance. The linear feature observed endoscopically (Figure 31) was revealed to be a diffuse surface mark, with no characteristics of a surface flaw or other injurious defect.

Figure 34: Linear features on the internal surfaces around the cylinder neck

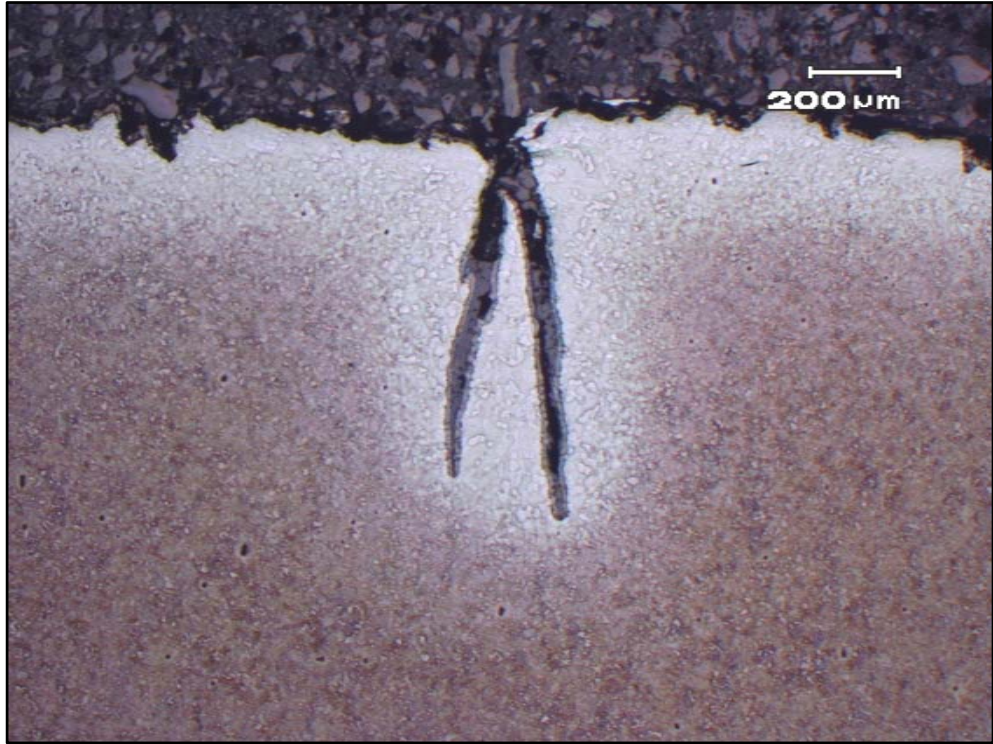
Figure 36: Largest of the internal surface intrusions identified around the cylinder neck transition

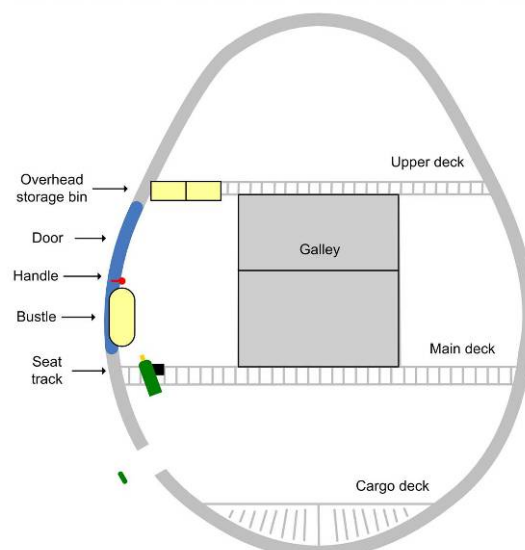
2. Cylinder failure produces fuselage rupture, with bulk of the cylinder length propelled upward through the cabin floor. See Figure 11.

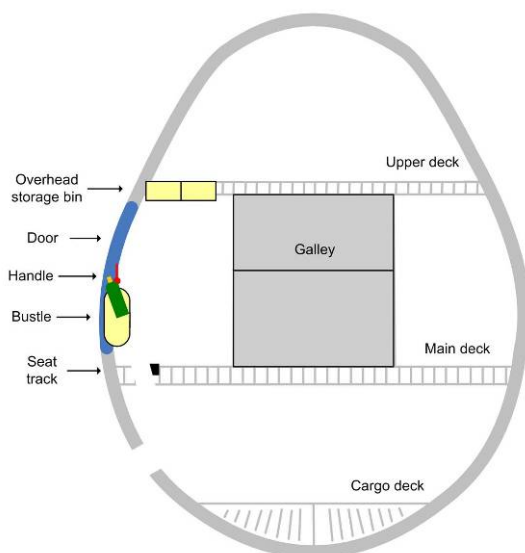
3. Cylinder impacts R2 door frame and internal door handle. See Figures 10 & 12.

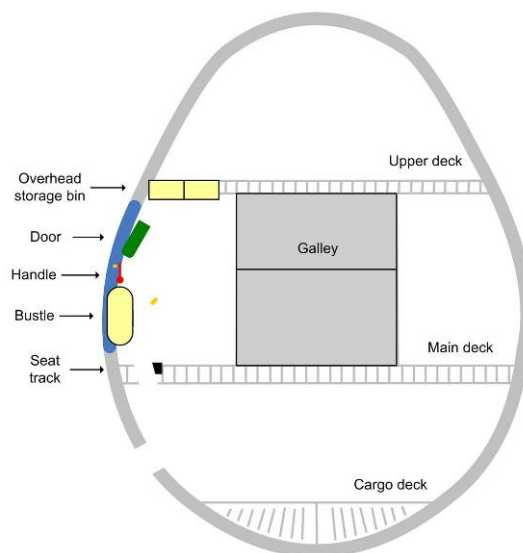
4. Door frame impact breaks off cylinder valve and causes cylinder to invert while continuing to travel upward.

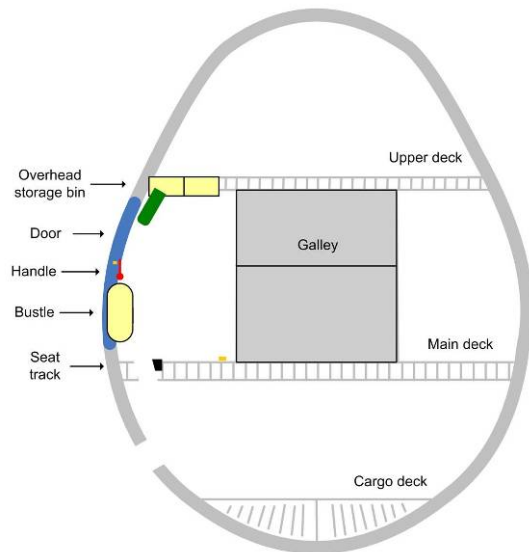
5. Cylinder impacts overhead panelling end-on, producing circular cut-out type damage. See Figures 14-16.

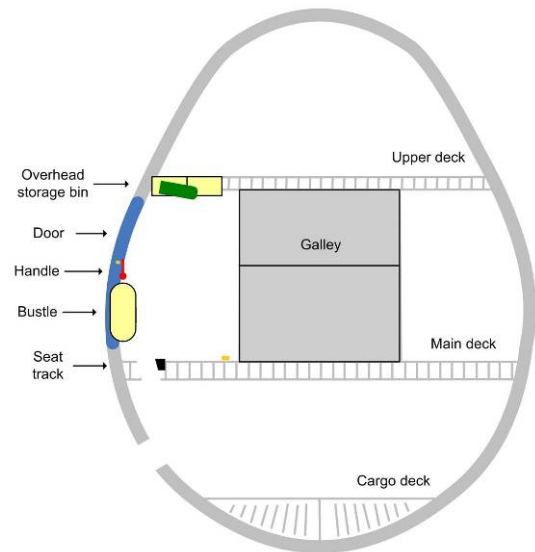
6. Still rotating cylinder impacts overhead storage bin, producing semi-circular crushing damage. See Figure 17.

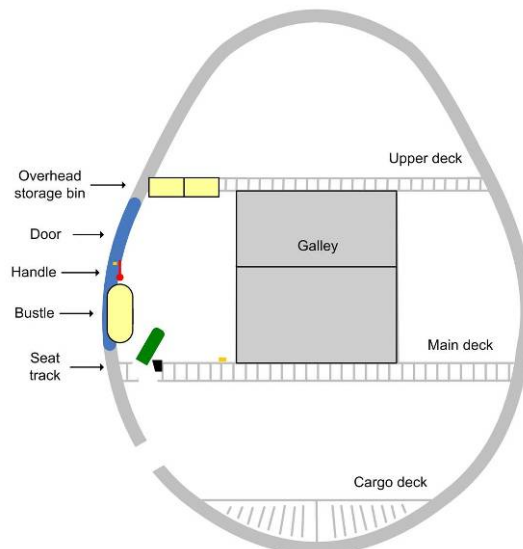
7. Cylinder falls to cabin floor and exits the aircraft through the ruptured fuselage.
