Interim report

on the accident on **1st June 2009**
to the **Airbus A330-203**
registered **F-GZCP**
operated by **Air France**
flight AF 447 Rio de Janeiro – Paris

Bureau d'Enquêtes et d'Analyses
pour la sécurité de l'aviation civile

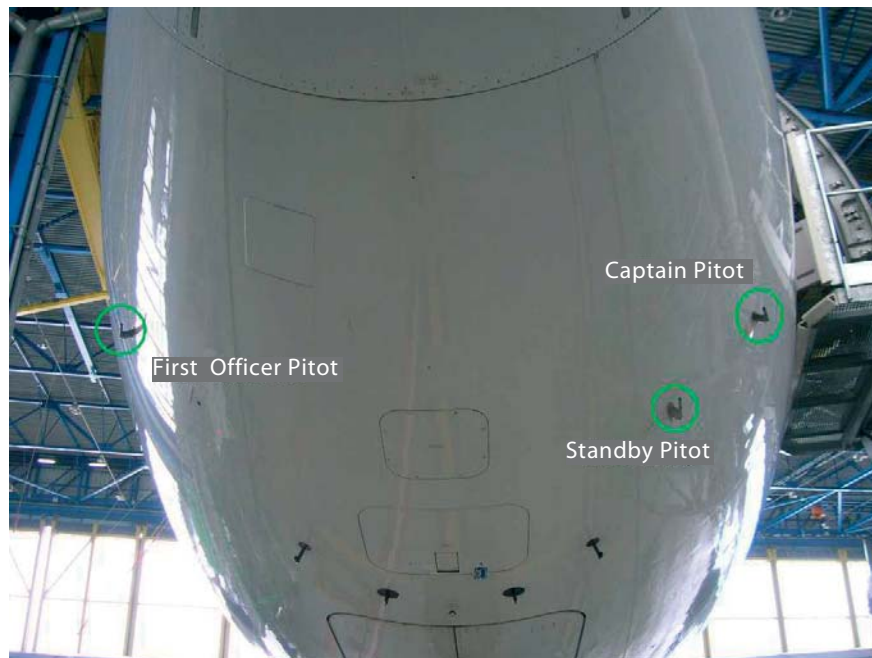
The Airbus A330 has three Pitot probes (see hereafter) and six static pressure pick-offs. These probes are fitted with drains allowing the removal of water, and with an electrical heating system designed to prevent them from icing up.

Position of the Pitot probes on the Airbus A330

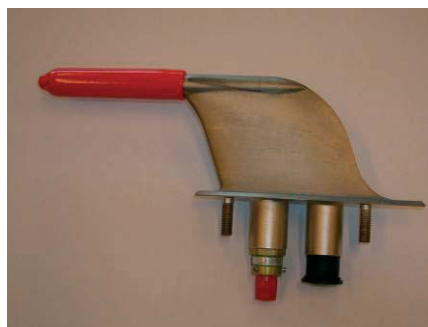
Pitot probe (with protection caps)

The Pitot probes are subject to a daily visual inspection by a mechanic, who checks their general condition. The crew performs the same type of check before each flight.

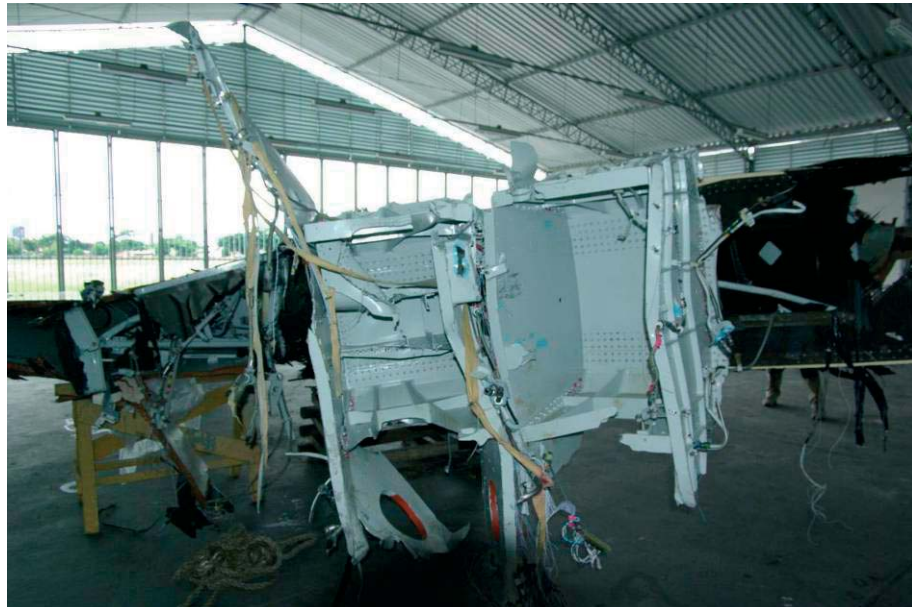
The tail fin was damaged during its recovery and transport but the photographs available made it possible to identify the damage that was not the result of the accident. The middle and rear fasteners with the related fragments of the fuselage hoop frames were present in the fin base. The distortions of the frames showed that they broke during a forward motion with a slight twisting component towards the left.

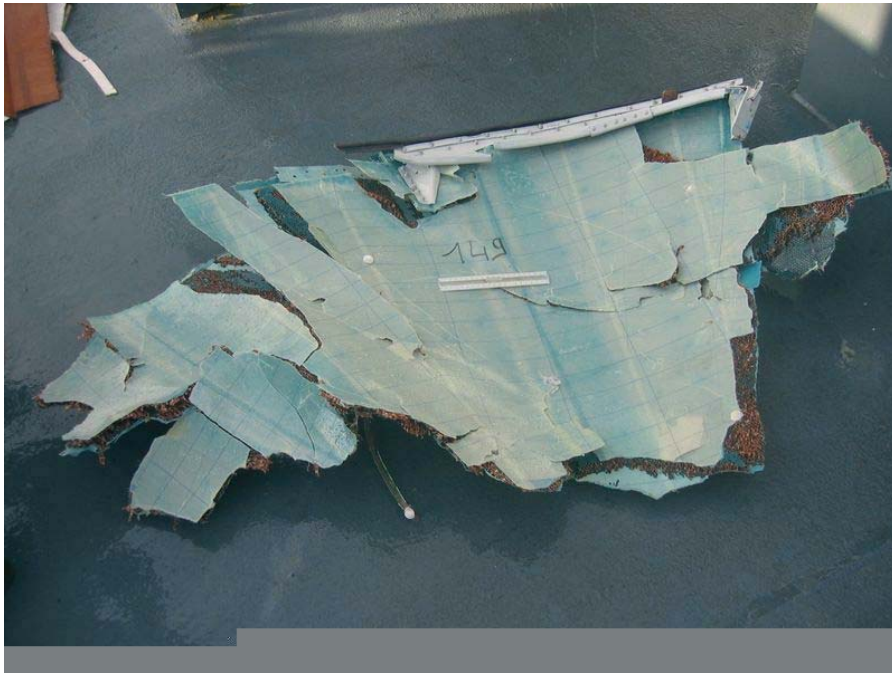
Part of the radome was found, representing approximately a fifth of its circumference along its upper part.

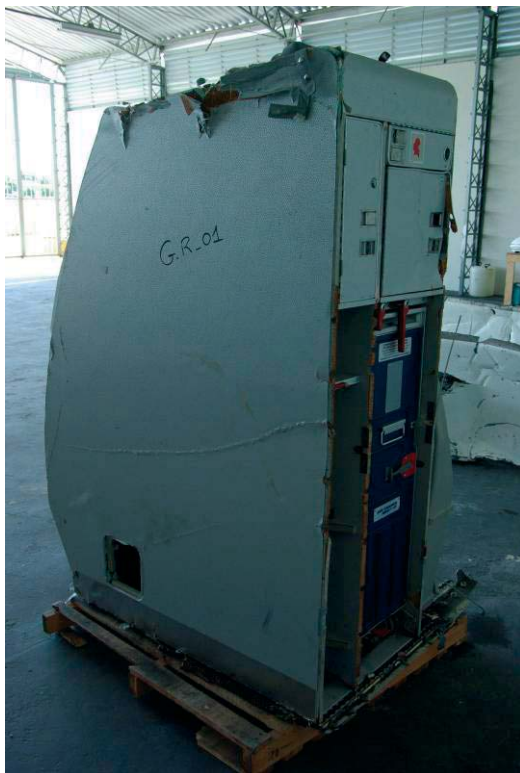
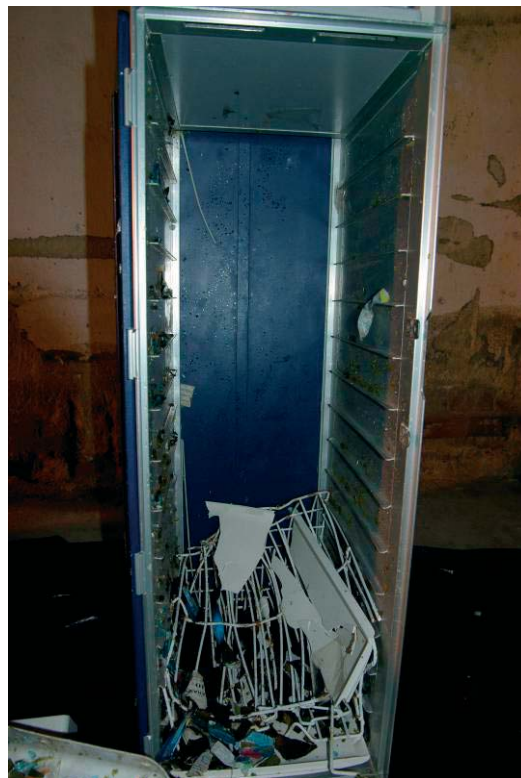
The galley, identified as G2, located at the level of door 2 on the right-hand side, was not very distorted. Baskets and racks were compressed in the lower part of both galley carts.

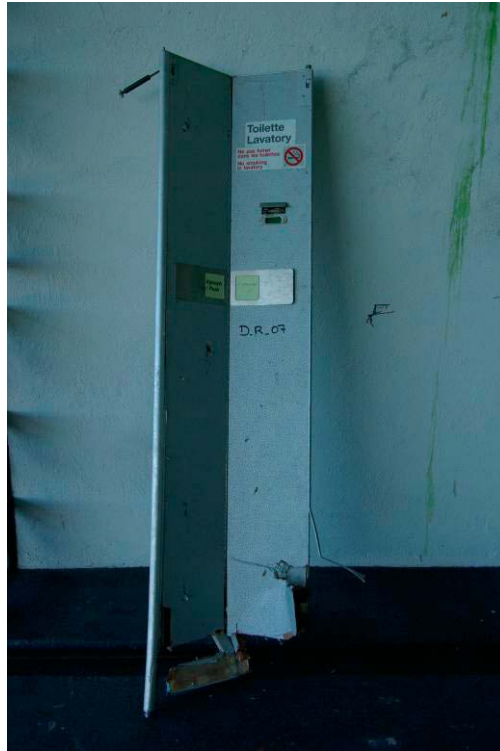
The distortions observed in the metal vertical reinforcements of a toilet door showed evidence of significant compressive forces.

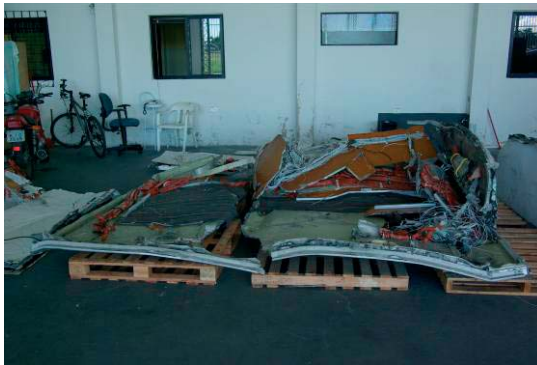
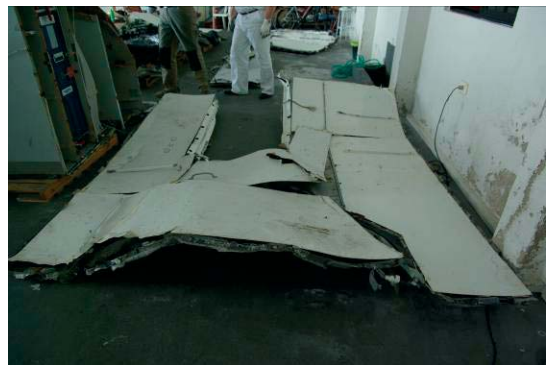
Fragments of the walls of the flight crew rest module were crumpled and those of the ceiling were deformed downwards. The floor was curved under the effect of a strong upward pressure from below. The connecting brackets between the floor and the walls were bent backwards.

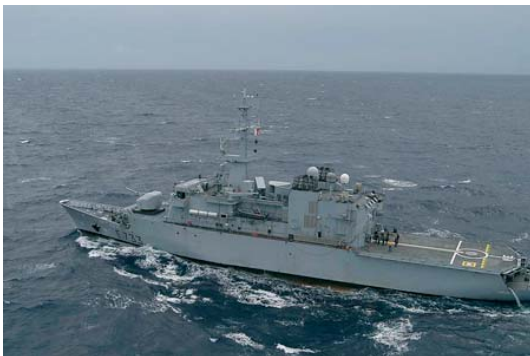
The French Navy deployed the frigate *Ventôse* and the Mistral BPC (projection and command ship), which have been taking part in the search and recovery operations for the bodies and floating debris. They have been assisted by their on-board helicopters and Naval Aviation and Air Force planes.

Ventôse frigate

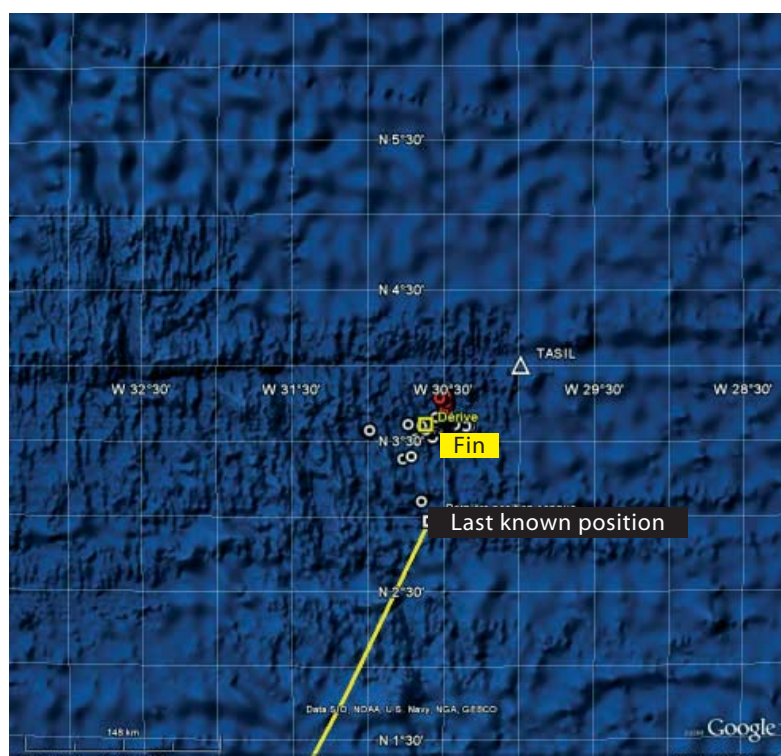
Bodies and wreckage recovered on 8 June
