Aviation Occurrence Investigation AO-2008-053

Interim Factual

**Depressurisation
475 km north-west of Manila, Philippines
25 July 2008
Boeing Company 747-438, VH-OJK**

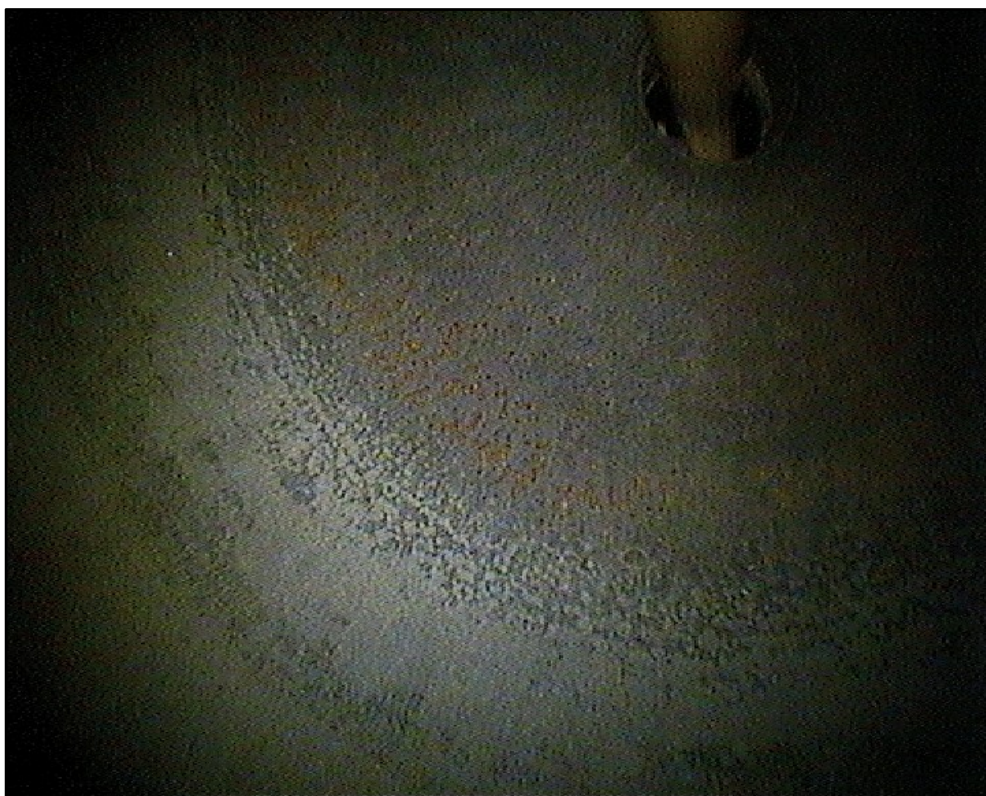
Figure 31: Linear feature observed inside cylinder SN: 535626 (arrowed)

After sectioning cylinder SN: 535626 to expose the internal surfaces, a fluorescent magnetic particle technique was employed to examine 100% of the internal surface area, including the linear feature observed during the endoscopic examination (Figure 31). While no evidence of crack-like features was observed within the cylinder body, multiple linear indications were detected radiating outward from the cylinder neck transition region (Figure 33). The longest of the indications extended for approximately 12 mm (0.5 in).

Prior to further sectioning for microstructural study, the internal surfaces of cylinder SN: 535626 were examined visually. It was noted that the internal surfaces at, and around the upper dome and neck transition, displayed a considerably coarser and irregular surface finish when compared with the general cylindrical and lower dome surfaces. A radial pattern of fissures and rivulet features was observed, becoming more prominent toward the neck (Figure 34). The entire surface in the region presented an oxidised or thick scale-like appearance. The linear feature observed endoscopically (Figure 31) was revealed to be a diffuse surface mark, with no characteristics of a surface flaw or other injurious defect.

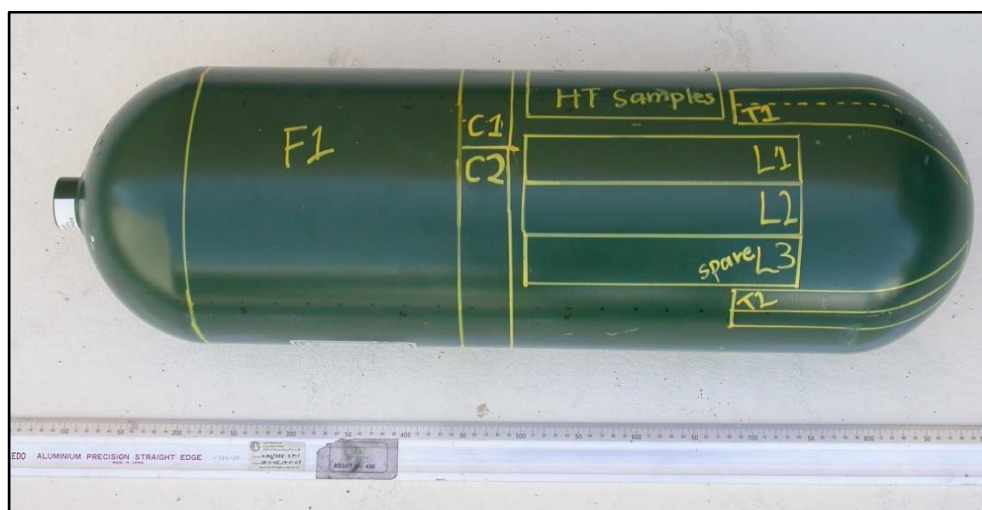
Figure 37: Cylinder SN: 535652 with locations of mechanical test specimens marked. L, T & C are the longitudinal, transition and circumferential tensile test specimens, F1 the flattening test specimen

A single flattening test as described in section I of CFR Title 49 §178.44, was prepared and tested from the upper cylindrical section of the cylinder. When flattened between knife edges having a 60° included angle and 12.5 mm (0.5 in) edge radii, the specimen cracked longitudinally at a knife edge separation of approximately 60 mm (2.4 in). As such, the test did not comply with the requirements specified by CFR Part 49 §178.44 section (p)(1), which stipulated “flattening required without cracking to ten times the wall thickness of the cylinder” (28 mm / 1.13 in).

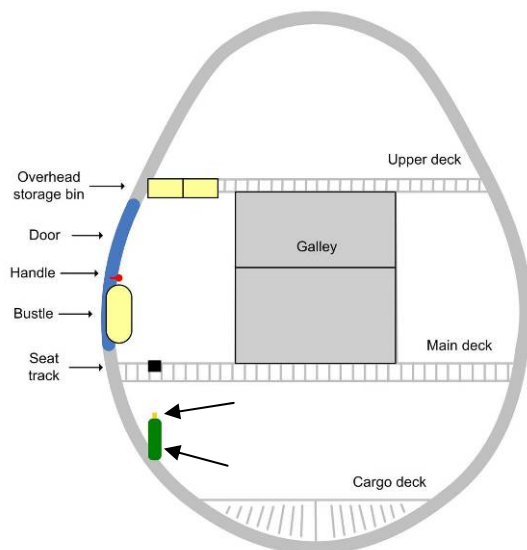
1. Normal arrangement (Oxygen cylinder and valve arrowed)
